Invisible Metallic Microfiber in Clothing Presents Unrecognized MRI Risk for Cutaneous Burn

J.A. Pietryga, M.A. Fonder, J.M. Rogg, D.L. North and L.G. Bercovitch

AJNR Am J Neuroradiol 2013, 34 (5) E47-E50 doi: https://doi.org/10.3174/ajnr.A2827 http://www.ajnr.org/content/34/5/E47

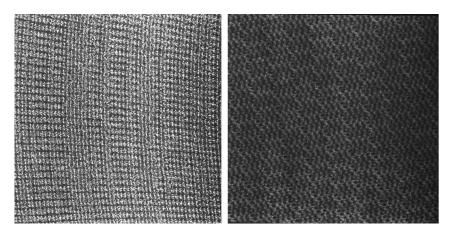
We suspect that our patient sustained cutaneous burns secondary to conductive SMF embedded in her undershirt. We retrospectively imaged the undershirt by high-resolution digital radiography (Fig 3) and demonstrated an interleaving weblike pattern of radiopaque SMF. We further demonstrated the enhanced electrical conductivity of the SMF fabric relative to control polyester and cotton fabrics by measuring the resistance by using a volt/ohm multimeter. The undershirt demonstrated low resistance (on the order of 10 ohms), which increased monotonically as a function of the distance separating the probes. In contrast, the resistance for both the cotton and polyester fabrics was infinite.

FIG 3. A digital radiograph demonstrating the metallic content of the fibers of the undershirt. Left image shows the radiopaque silver microweave fabric from the Boston Silver T. Comparison right image shows cotton fabric from a thermal undershirt.
