MRI Head Coil Malfunction Producing Artifacts Mimicking Malformation of Cortical Development in Pediatric Epilepsy Work-Up

AJNR Am J Neuroradiol 2020, 41 (8) 1538-1540

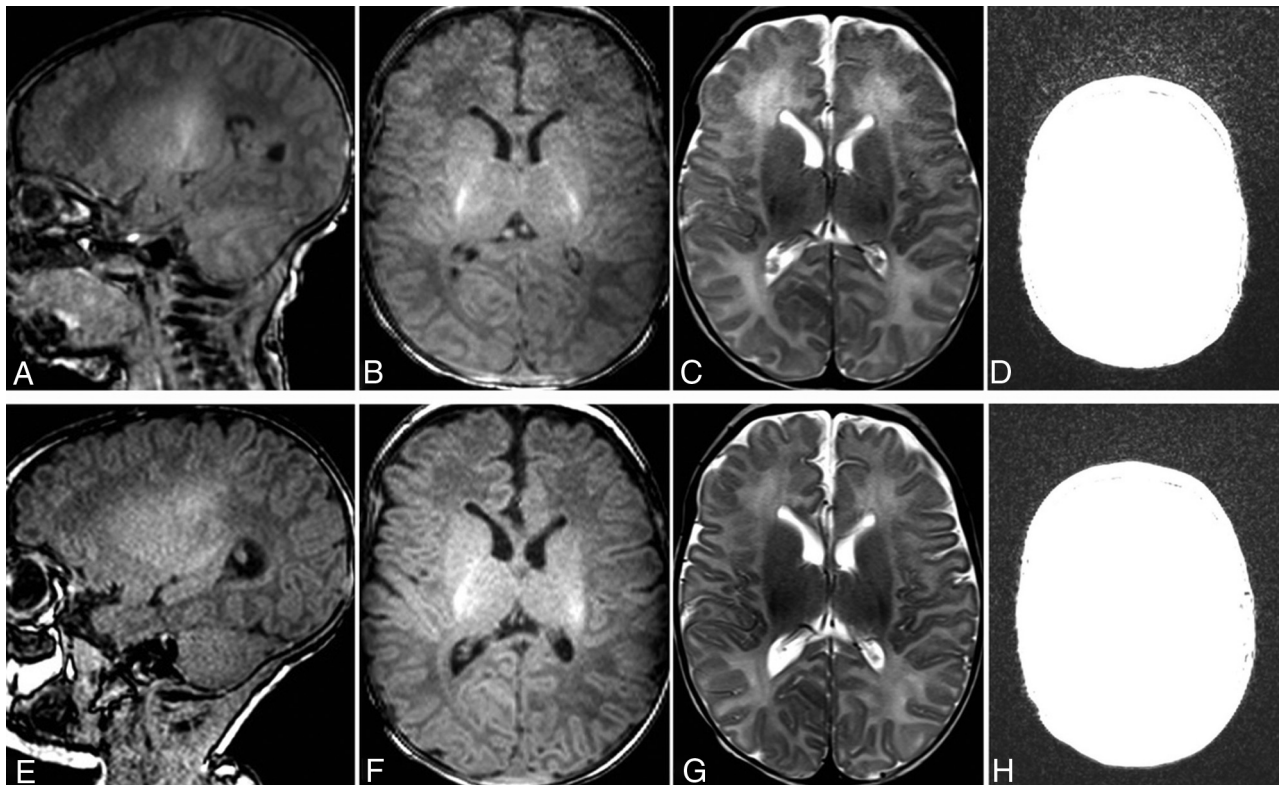
Case 1. A 2-week-old term male neonate was admitted with suspected bacterial meningitis. A brain MR imaging was requested to rule out any complications from meningitis. The MR imaging was performed (3T Magnetom Vida; Siemens), including 3D MPRAGE T1WI, axial and coronal FSE T2WI, DWI, gradient-echo T2*-weighted images, TOF-MRA, and phase-contrast MRV. A 20-channel head coil was used. A small amount of pus in the trigones of both lateral ventricles was identified, and bilateral frontal cerebral cortex surfaces as well as cortical white matter junctions appeared irregular, while their signal intensities were normal on all sequences. The findings were interpreted as possible polymicrogyria (Fig 2A,–C).

Repeat MR imaging was performed 20 days later on the same scanner with identical sequences and coils. The frontal cerebral cortex now appeared normal, and the previously seen irregular outer and inner surfaces of the frontal cortex were no longer present (Fig 2E,–G). Therefore, a coil malfunction was suspected. Scanning parameters of the first scan were then reviewed, and it was noted that the anterior 2 groups of the coil elements were “off.”

of MR imaging artifact on a 3T scanner that causes apparent irregularity of the cerebral cortex, mimicking an abnormal appearance of the cerebral cortex and leading to initial misinterpretation. This type of artifact was caused by a loosened connection of the anterior 2 groups of the multichannel head coil. The authors could not find any description of such an artifact in the English language literature.

FIG 2. MR imaging of the brain of case 1 at presentation (A–D) and 20 days later (E–H). On the sagittal and axial T1WI (A and B) and the axial T2WI (C) of the first scan, the cerebral cortices of the bilateral frontal lobes show apparent irregular surfaces and gray-white matter junctions. Because the irregularity was observed on both T1WI and T2WI and the posterior cerebral cortices have rather smooth surfaces, without knowing the possibility of coil malfunction, we interpreted the findings as possible polymicrogyria. On the sagittal and axial T1WI (E and F) and the axial T2WI (G) of the follow-up scan obtained only 20 days later, the irregularity is no longer present, suggesting that the irregular appearance of the cortex seen on the first scan is artifactual rather than pathologic. When the window setting was adjusted to evaluate the background noise of the axial T1WI of the first (D) and follow-up (H) scan, it is obvious that the first scan has pronounced background noise in the frontal part of the image.

The apparent cortical irregularity simulates malformation of cortical development. Indeed, we misinterpreted this artifact as a polymicrogyria in our first patient. Fortunately, the patient had a repeat MR imaging not long after, and no harm was done to the patient. MR imaging technologists and radiologists should be vigilant for this type of artifact. Unlike other MR imaging artifacts, this type of artifact persists and appears on all the sequences of any acquisition plane if not recognized. The radiologist should not conclude that the apparent cortical irregularity is not artifactual because the cortical irregularity can be seen on all sequences. Bilateral and symmetric abnormalities should raise suspicion for the presence of such an artifact. It can be easily confirmed by adjusting the window setting of the images and visualization of a pronounced frontal background noise (Fig 2D and On-line Figs 1B and 2B). The artifact can be corrected by re-plugging the head coil. Of note, our case series consists of only 3 patients, and the
