**MRI Head Coil Malfunction Producing
Artifacts Mimicking Malformation of
Cortical Development in Pediatric Epilepsy
Work-Up**

N. Kashani, N. Khan, J.M. Ospel and X.-C. Wei

AJNR Am J Neuroradiol 2020, 41 (8) 1538-1540

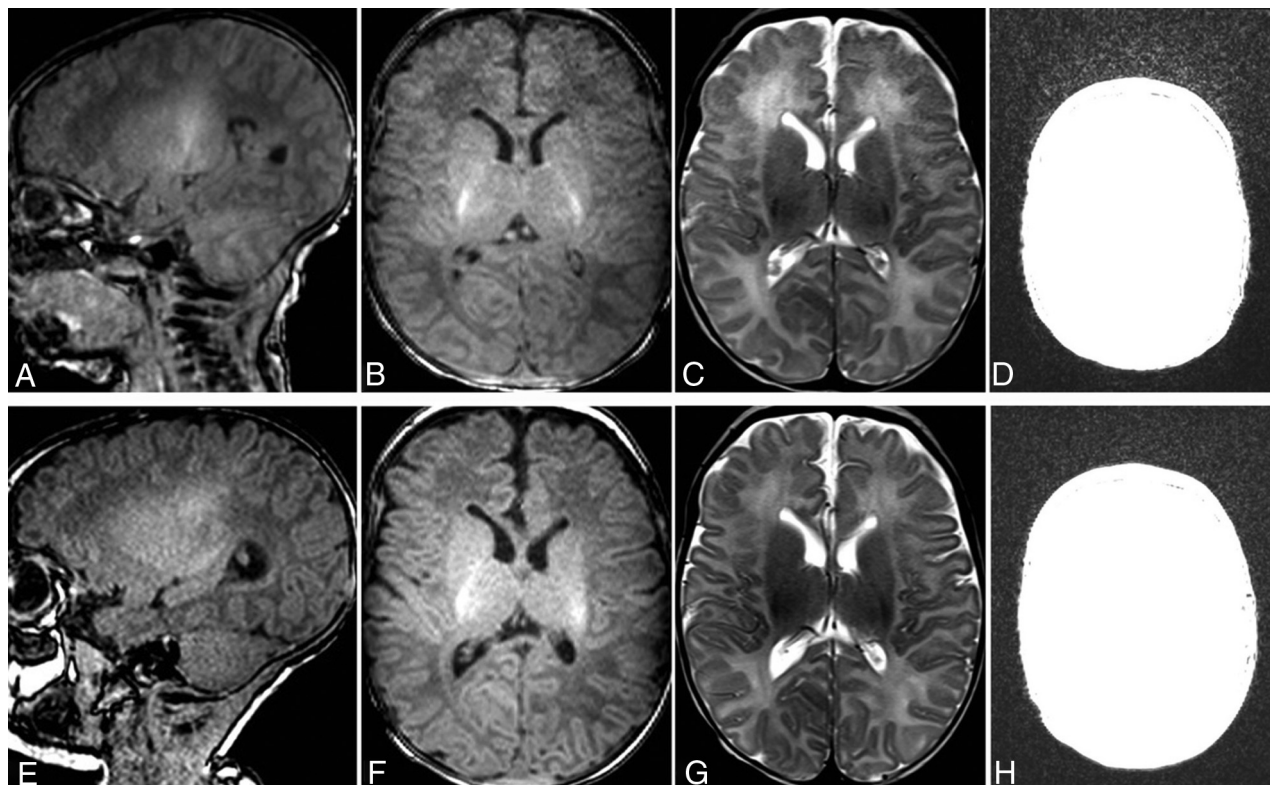
Case 1. A 2-week-old term male neonate was admitted with suspected bacterial meningitis. A brain MR imaging was requested to rule out any complications from meningitis. The MR imaging was performed (3T Magnetom Vida; Siemens), including 3D MPRAGE T1WI, axial and coronal FSE T2WI, DWI, gradient-echo T2*-weighted images, TOF-MRA, and phase-contrast MRV. A 20-channel head coil was used. A small amount of pus in the trigones of both lateral ventricles was identified, and bilateral frontal cerebral cortex surfaces as well as cortical white matter junctions appeared irregular, while their signal intensities were normal on all sequences. The findings were interpreted as possible polymicrogyria (Fig 2A,–C).

Repeat MR imaging was performed 20 days later on the same scanner with identical sequences and coils. The frontal cerebral cortex now appeared normal, and the previously seen irregular outer and inner surfaces of the frontal cortex were no longer present (Fig 2E,–G). Therefore, a coil malfunction was suspected. Scanning parameters of the first scan were then reviewed, and it was noted that the anterior 2 groups of the coil elements were “off.”

of MR imaging artifact on a 3T scanner that causes apparent irregularity of the cerebral cortex, mimicking an abnormal appearance of the cerebral cortex and leading to initial misinterpretation. This type of artifact was caused by a loosened connection of the anterior 2 groups of the multichannel head coil. The authors could not find any description of such an artifact in the English language literature.

FIG 2. MR imaging of the brain of case 1 at presentation (A–D) and 20 days later (E–H). On the sagittal and axial T1WI (A and B) and the axial T2WI (C) of the first scan, the cerebral cortices of the bilateral frontal lobes show apparent irregular surfaces and gray-white matter junctions. Because the irregularity was observed on both T1WI and T2WI and the posterior cerebral cortices have rather smooth surfaces, without knowing the possibility of coil malfunction, we interpreted the findings as possible polymicrogyria. On the sagittal and axial T1WI (E and F) and the axial T2WI (G) of the follow-up scan obtained only 20 days later, the irregularity is no longer present, suggesting that the irregular appearance of the cortex seen on the first scan is artifactual rather than pathologic. When the window setting was adjusted to evaluate the background noise of the axial T1WI of the first (D) and follow-up (H) scan, it is obvious that the first scan has pronounced background noise in the frontal part of the image.

The apparent cortical irregularity simulates malformation of cortical development. Indeed, we misinterpreted this artifact as a polymicrogyria in our first patient. Fortunately, the patient had a repeat MR imaging not long after, and no harm was done to the patient. MR imaging technologists and radiologists should be vigilant for this type of artifact. Unlike other MR imaging artifacts, this type of artifact persists and appears on all the sequences of any acquisition plane if not recognized. The radiologist should not conclude that the apparent cortical irregularity is not artifactual because the cortical irregularity can be seen on all sequences. Bilateral and symmetric abnormalities should raise suspicion for the presence of such an artifact. It can be easily confirmed by adjusting the window setting of the images and visualization of a pronounced frontal background noise (Fig 2D and On-line Figs 1B and 2B). The artifact can be corrected by re-plugging the head coil. Of note, our case series consists of only 3 patients, and the
