Invisible Metallic Microfiber in Clothing Presents Unrecognized MRI Risk for Cutaneous Burn

AJNR Am J Neuroradiol published online 15 December
2011

TECHNICAL NOTE

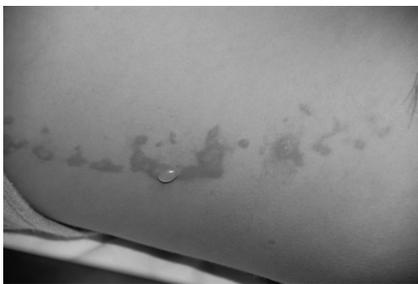
Following patient arousal from sedation, she complained of right-sided “burning” discomfort. Physical examination revealed linear erythematous blistering eruptions located along her right flank (Fig 1) and ipsilateral volar wrist where it contacted the undershirt. A dermatologic consult diagnosed a second-degree burn.

We hypothesize that during the study, electromagnetic eddy currents generated either within the shirt fibers concentrated at the fabric seam or between the shirt fabric seam and the patient’s moist midaxillary skin resulted in significant heating and second-degree burns.

Fig 1. A linear erythematous blistering eruption is noted on the patient's right flank minutes after completion of the MR imaging of her brain and spine.

In summary, we demonstrate how, despite careful pre-screening, invisible metallic microfiber in garments can fail to be detected before entering the MR imaging environment and potentially lead to patient thermal burns. To avoid this hazard, all patients should change into site-supplied MR imaging-compatible outer clothing and wear nonmetallic cotton or other safe non-trade name undergarments for their examinations. When exception is necessary, only patients wearing clearly labeled nonmetallic, non-trade name fabrics should be scanned without changing. We believe that those patients who

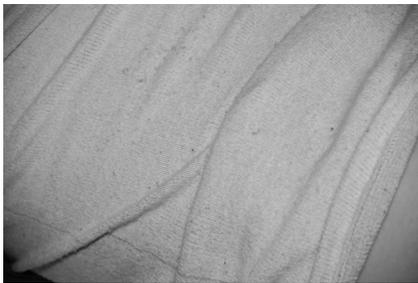
Fig 2. The patient wore a Boston Silver T shirt beneath a conventional cotton tee shirt during her imaging study. It was not until after the scan that it was realized that the undershirt, recommended for wear beneath her back brace, contained antimicrobial silver microfibers.

Our patient's Boston Silver T shirt showed no visible or labeling evidence to indicate that it contained SMF and was purchased to be used under external appliances (eg, a back brace) because of its perspiration wicking and antimicrobial characteristics. The manufacturer has since voluntarily modified its label to identify the silver content with the trade label X-Static (Nobel Biomaterials, Scranton, Pennsylvania) and to specifically warn against use during MR imaging examinations. The shirt still contains no attached content label.

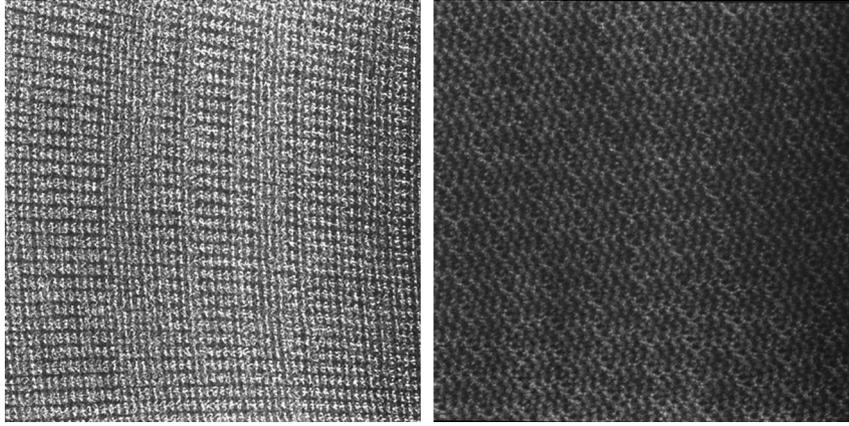
We suspect that our patient sustained cutaneous burns secondary to conductive SMF embedded in her undershirt. We retrospectively imaged the undershirt by high-resolution digital radiography (Fig 3) and demonstrated an interleaving weblike pattern of radiopaque SMF. We further demonstrated the enhanced electrical conductivity of the SMF fabric relative to control polyester and cotton fabrics by measuring the resistance by using a volt/ohm multimeter. The undershirt demonstrated low resistance (on the order of 10 ohms), which increased monotonically as a function of the distance separating the probes. In contrast, the resistance for both the cotton and polyester fabrics was infinite.

Fig 3. A digital radiograph demonstrating the metallic content of the fibers of the undershirt. Left image shows the radiopaque silver microweave fabric from the Boston Silver T. Comparison right image shows cotton fabric from a thermal undershirt.
