TECHNICAL NOTE

Invisible Metallic Microfiber in Clothing Presents Unrecognized MRI Risk for Cutaneous Burn

SUMMARY: We report a case of a thermal burn that occurred during MR imaging likely caused by invisible silver-embedded microfibers in the fabric of an undershirt. As the prevalence of fabric containing nondetectable metallic microfiber increases in athletic and “tech” clothing, the importance of having patients change into safe facility-provided garments before MR imaging is emphasized.

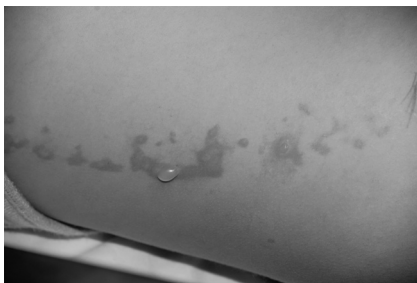
Following patient arousal from sedation, she complained of right-sided “burning” discomfort. Physical examination revealed linear erythematous blistering eruptions located along her right flank (Fig 1) and ipsilateral volar wrist where it contacted the undershirt. A dermatologic consult diagnosed a second-degree burn.

Scan sequences, SAR parameters, and coil and cable placements during the examination were reviewed, and no deviation from normal parameters was found. Review of the images showed no evidence of artifacts on the thoracic series, which included the site of blistering, though the specific location of the cutaneous flank burn was not included within the image FOV. While exploring potential sources for the burn with the patient and her family, the patient noted that her undershirt was called the “Boston Silver T” by the National Orthotics and Prosthetics Company store (Boston Brace International, Avon, Massachusetts), where it was purchased (Fig 2). The family had not been informed that the shirt contained SMF. The shirt contents were identified as Coolmax/Lycra, (INVISTA, Wichita, Kansas) without mention of SMF. Only after we called the manufacturer, Comfort Products (Croydon, Pennsylvania), was it determined that the shirt fabric was impregnated with SMF. On careful review of the shirt, it was noted that the midaxillary burn corresponded with the single shirt seam.

We hypothesize that during the study, electromagnetic eddy currents generated either within the shirt fibers concentrated at the fabric seam or between the shirt fabric seam and the patient's moist midaxillary skin resulted in significant heating and second-degree burns.

Fig 1. A linear erythematous blistering eruption is noted on the patient's right flank minutes after completion of the MR imaging of her brain and spine.

In summary, we demonstrate how, despite careful pre-screening, invisible metallic microfiber in garments can fail to be detected before entering the MR imaging environment and potentially lead to patient thermal burns. To avoid this hazard, all patients should change into site-supplied MR imaging-compatible outer clothing and wear nonmetallic cotton or other safe non-trade name undergarments for their examinations. When exception is necessary, only patients wearing clearly labeled nonmetallic, non-trade name fabrics should be scanned without changing. We believe that those patients who

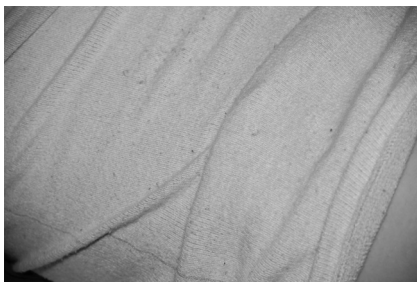
Fig 2. The patient wore a Boston Silver T shirt beneath a conventional cotton tee shirt during her imaging study. It was not until after the scan that it was realized that the undershirt, recommended for wear beneath her back brace, contained antimicrobial silver microfibers.

Our patient's Boston Silver T shirt showed no visible or labeling evidence to indicate that it contained SMF and was purchased to be used under external appliances (eg, a back brace) because of its perspiration wicking and antimicrobial characteristics. The manufacturer has since voluntarily modified its label to identify the silver content with the trade label X-Static (Nobel Biomaterials, Scranton, Pennsylvania) and to specifically warn against use during MR imaging examinations. The shirt still contains no attached content label.

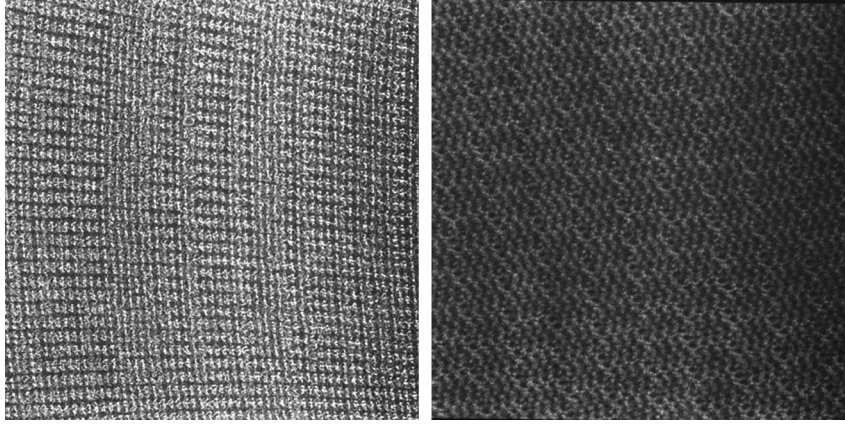
We suspect that our patient sustained cutaneous burns secondary to conductive SMF embedded in her undershirt. We retrospectively imaged the undershirt by high-resolution digital radiography (Fig 3) and demonstrated an interleaving weblike pattern of radiopaque SMF. We further demonstrated the enhanced electrical conductivity of the SMF fabric relative to control polyester and cotton fabrics by measuring the resistance by using a volt/ohm multimeter. The undershirt demonstrated low resistance (on the order of 10 ohms), which increased monotonically as a function of the distance separating the probes. In contrast, the resistance for both the cotton and polyester fabrics was infinite.

electromagnetic eddy currents generated within the shirt fiber concentrated at the fabric seam and led to second degree skin burns along the sites of skin contact. Because the undershirt was longer than the overlying shirt, her right wrist was in direct contact with the seam and was also affected.

Fig 3. A digital radiograph demonstrating the metallic content of the fibers of the undershirt. Left image shows the radiopaque silver microweave fabric from the Boston Silver T. Comparison right image shows cotton fabric from a thermal undershirt.
