**Invisible Metallic Microfiber in Clothing
Presents Unrecognized MRI Risk for
Cutaneous Burn**

AJNR Am J Neuroradiol 2013, 34 (5) E47-E50

ABSTRACT

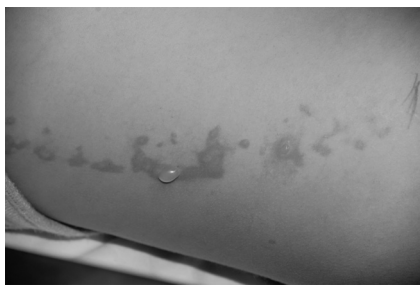
Following patient arousal from sedation, she complained of right-sided “burning” discomfort. Physical examination revealed linear erythematous blistering eruptions located along her right flank (Fig 1) and ipsilateral volar wrist where it contacted the undershirt. A dermatologic consult diagnosed a second-degree burn.

FIG 1. A linear erythematous blistering eruption is noted on the patient's right flank minutes after completion of the MR imaging of her brain and spine.

We hypothesize that during the study, electromagnetic eddy currents generated either within the shirt fibers concentrated at the fabric seam or between the shirt fabric seam and the patient's moist midaxillary skin resulted in significant heating and second-degree burns.

In summary, we demonstrate how, despite careful prescreening, invisible metallic microfiber in garments can fail to be detected before entering the MR imaging environment and potentially lead to patient thermal burns. To avoid this hazard, all patients should change into site-supplied MR imaging-compatible outer clothing and wear nonmetallic cotton or other safe non-trade name undergarments for their examinations. When exception is necessary, only patients wearing clearly labeled nonmetallic, non-trade name fabrics should be scanned without changing. We believe that those patients who are sedated or otherwise have diminished responsiveness are at greatest risk for thermal burns and, therefore, require the greatest scrutiny.

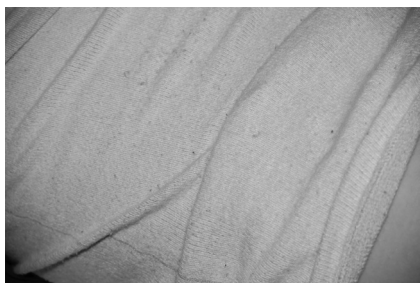
FIG 2. The patient wore a Boston Silver T shirt beneath a conventional cotton tee shirt during her imaging study. It was not until after the scan that it was realized that the undershirt, recommended for wear beneath her back brace, contained antimicrobial silver microfibers.

don, Pennsylvania), was it determined that the shirt fabric was impregnated with SMF. On careful review of the shirt, it was noted that the midaxillary burn corresponded with the single shirt seam.

Our patient's Boston Silver T shirt showed no visible or labeling evidence to indicate that it contained SMF and was purchased to be used under external appliances (eg, a back brace) because of its perspiration wicking and antimicrobial characteristics. The manufacturer has since voluntarily modified its label to identify the silver content with the trade label X-Static (Nobel Biomaterials, Scranton, Pennsylvania) and to specifically warn against use during MR imaging examinations. The shirt still contains no attached content label.
