AJNR

Buffing Up MR Images

Summary: The authors describe an innovative approach to buffing up MR images.

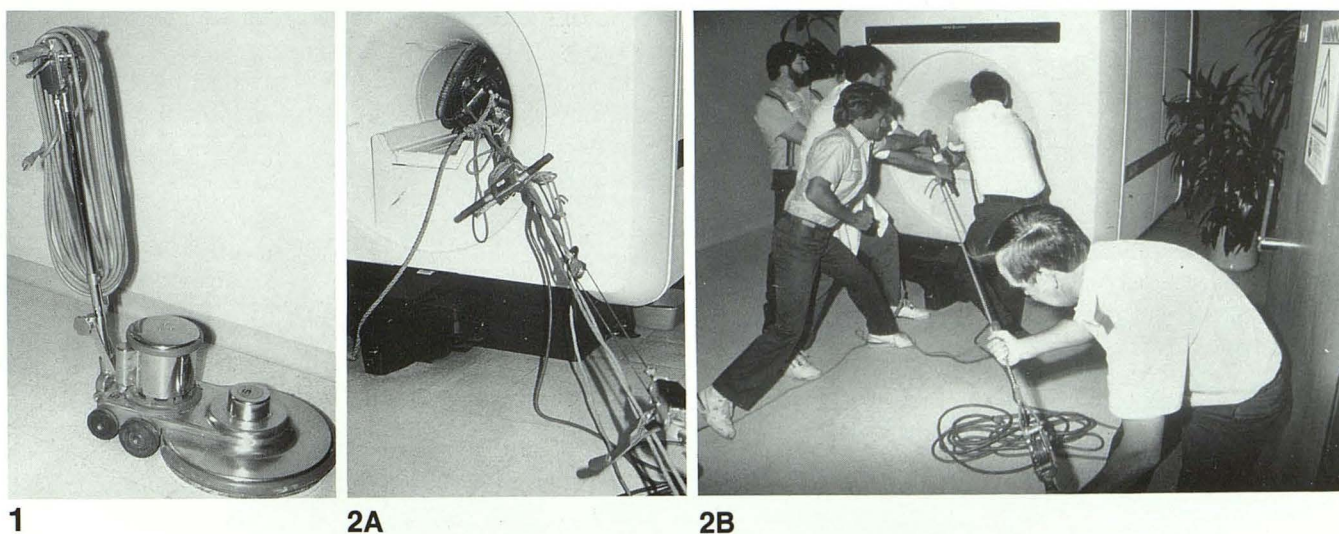
Fig. 1. The model SSS 1040 Ultra High Speed floor wax buffer.

Fig. 2. A and B, Attempted extraction of the buffer from the magnet bore.

Upon crossing the threshold of the magnet room, the floor buffer was pulled from the grasp of the maintenance employee and propelled to a final resting place within the bore of the magnet. Attempts to extract the buffer from the magnet with a block and tackle were unsuccessful (Fig. 2). After incrementally ramping down the magnetic field strength by using the shim power supply, the floor buffer was successfully removed from the bore of the magnet.

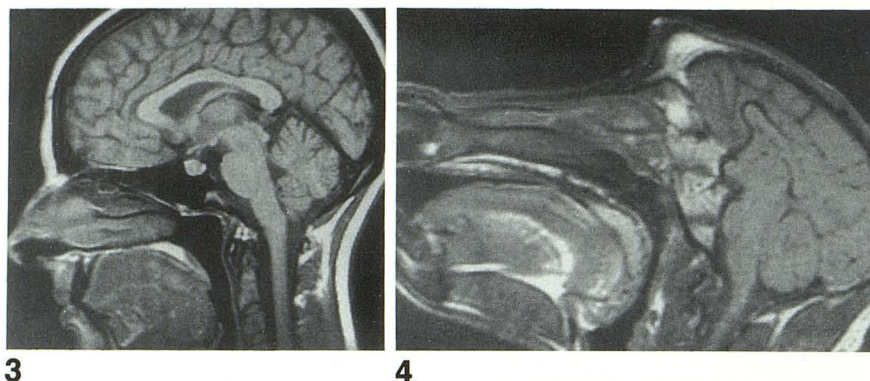
Fig. 3. Sagittal 500/30 (TR/TE) T1-weighted image of the head prior to the buffer upgrade.

Fig. 4. Sagittal 500/30 T1-weighted image of the head post-buffer upgrade. Note the improved visualization of the facial structures and of the anterior cerebral artery as compared to Figure 3.

Although minor albeit costly cosmetic repairs were necessitated by the aforementioned buffer upgrade, a significant improvement in image quality resulted. Standard T1-weighted sagittal images of the brain obtained prior to the buffer upgrade are illustrated in Figure 3. Routine post-upgrade images are illustrated in Figure 4.
