*AJNR Am J Neuroradiol* 1995, 16 (7) 1517-1524

# Postoperative Imaging of the Multichannel Cochlear Implant

Barry A. Shpizner, Roy A. Holliday, J. Thomas Roland, Noel L. Cohen, Susan B. Waltzman, and William H. Shapiro

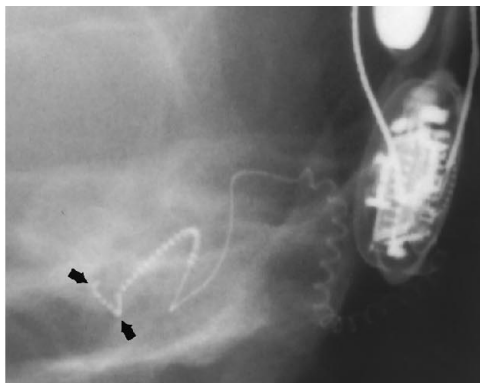
Fig 8. A, Postoperative anteroposterior view demonstrates an abnormal curvature to the electrode array (*arrows*). The absence of well-defined otic capsule structures precludes identification of the cochlear promontory. Extracochlear placement is suspected.

The depth of insertion of the electrode array (number of electrodes and stiffening rods within the cochlea) was estimated surgically in each patient by counting the number of elements that passed through the cochleostomy. The depth of insertion was estimated radiographically by counting the number of elements relative to the cochlear promontory (Fig 3). Electrodes that projected medial to the lateral margin of the cochlear promontory were considered intracochlear. The cochlear promontory, which is identified as the air-bone interface just caudal to the vestibule (10), was confidently identified on 128 intraoperative studies and on 30 postoperative studies. Failure to identify the cochlear promontory on 7 intraoperative films was attributable to patient rotation toward either the lateral or craniad projection. The cochlear promontory could not be identified on postoperative films in one patient with vestibulocochlear dysplasia because of failure to identify otic capsule landmarks (see Fig 8A).

tients. Five of these patients subsequently had CT scans for electrode array location. A CT scan was not obtained on the sixth patient, who was treated at another facility. In all patients the electrode array was bent or compressed or had an atypical configuration (Figs 6A and 7A). In one patient the exact location of the array could not be determined, in part, because of the absence of well-defined otic capsule structures (Fig 8A).
