**Black Holes on MR Images of the Brain of  
Patients with Björk-Shiley Heart Valves:  
Additional Observation in Three Cases**

*AJNR Am J Neuroradiol* 2003, 24 (3) 512-514  
<http://www.ajnr.org/content/24/3/512>

# Black Holes on MR Images of the Brain of Patients with Björk-Shiley Heart Valves: Additional Observation in Three Cases

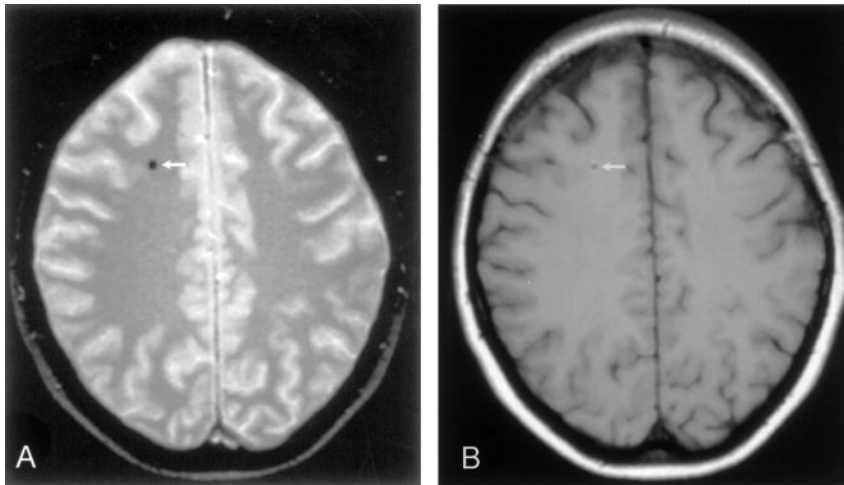
FIG 1. Patient 2.

A, Axial view T2\*-weighted gradient-echo image (710/27.6/2 [TR/TE/number of excitations]) shows a black hole (arrow). Repeat images obtained after 1 year appeared unchanged, with no increase in number or size of black holes (not shown).

B, Corresponding axial view T2-weighted spin-echo image (1380/60/2) shows the same black hole with a typical white halo (arrow).

The substances that could be responsible for these susceptibility artifacts can be divided approximately into four different groups: air, calcium, microhemorrhages, and foreign metallic particles. Air can be ruled out because of expected resolution over time, which we did not observe on the second set of images obtained for patient 2 after 1 year. As for calcium deposits, these have slightly distinct appearances on MR images and lack the white halo, which was clearly visible on the T2-weighted spin-echo sequence of pa-

tient 2 (Fig 1B). In addition, the blooming of signal intensity loss on the T2\*-weighted gradient-echo sequence is not observed with calcium deposits.

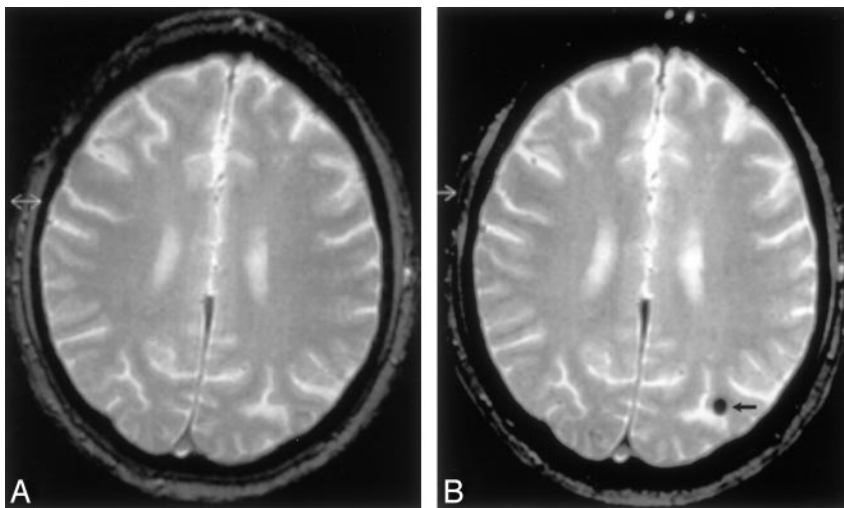
FIG 2. Patient 3.

A, Axial view T2\*-weighted gradient-echo image (710/27.6/2), obtained 1 week before double valve replacement, shows no apparent abnormalities.

B, Axial view T2\*-weighted gradient-echo image (710/27.6/2), obtained 5 months after successful double valve replacement, shows one of the two large black holes (arrow).

Interestingly enough, the images of patient 3 showed artifacts after the Björk-Shiley convexo-concave valve explantation and not before. When valve wear or damage is considered for this patient, one would expect that the "exposure time" of the valve to the circulation was sufficient to cause some artifacts. In addition, no cracks or fractures were discovered with scanning electron microscopy research after valve removal, although common valve wear was obvious. Based on the postoperative changes seen on the MR images, it seems that surgery played a more important role in the formation of these artifacts. This could also be the case for the first two patients for whom we did not have MR images of the brain before explantation. If intensive cardiac surgery were to induce these artifacts, however (ie, by means of surgical instrumentation or cardiopulmonary bypass machines), one would expect to observe it more frequently in daily practice. This may be explained in part by considering that patients with prosthetic heart valves often are unjustly withheld from MR imaging investigation because of fear of valve failure being induced by the magnetic field (14). Moody et al (15) have reported extensively on microembolic phenomena associated with cardiopulmonary bypass, combining clinical presentations and histochemical staining. Unfortunately, in our cases, no pathologic or histochemical evidence is available. In general, detrimental effects on the brain after cardiopulmonary bypass
