Sacroplasty: A Treatment for Sacral Insufficiency Fractures

William Pommersheim, Frank Huang-Hellinger, Michael Baker and Pearse Morris

AJNR Am J Neuroradiol 2003, 24 (5) 1003-1007 http://www.ajnr.org/content/24/5/1003

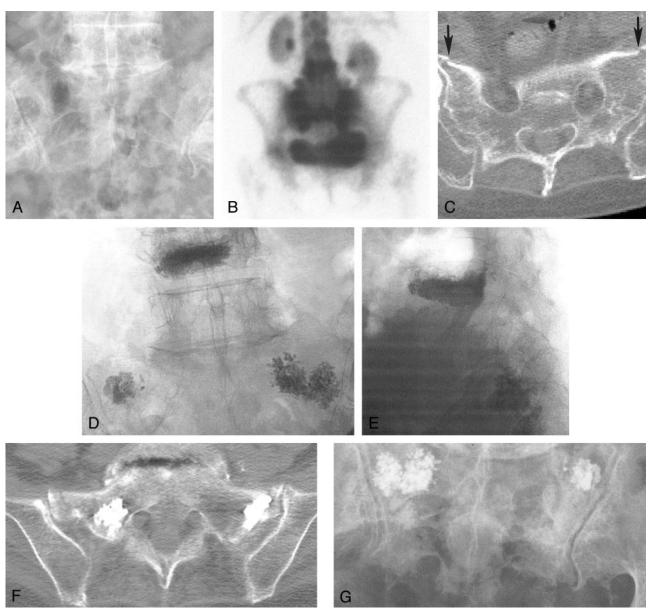
Fig 1. Case 1, a 76-year-old woman with low back pain.

- A, Pelvic radiograph shows degenerative lumbar changes. Note, however, that the sacrum is unremarkable.
- B, Bone scan shows the H sign diagnostic of a sacral insufficiency fracture. Prominent renal activity on the scan is a normal finding.
- C, Cortical disruption (arrows) on a non-contrast-enhanced pelvic CT scan confirms fracture.
- D and E, Anteroposterior (D) and lateral (E) fluoroscopic images show cement in the L4 vertebral body and cement bilaterally in the sacral ala. The lateral view illustrates the difficulty with visualization within the sacrum during this technique.
 - F, Postoperative pelvic CT scan shows cement within the bilateral superior sacral ala in the vicinity of the fracture lines
 - G, Follow-up pelvic radiograph shows the cement within the superior sacrum

A 76-year-old woman was referred for vertebroplasty for intermittent chronic lower back pain recently aggravated by a fall. The severity of her pain necessitated a wheelchair for mobility. During examination, she reported tenderness over L4, but her severe sacral pain dominated her presentation. Although a pelvic radiograph (Fig 1A) was normal, bone scintigraphy (Fig 1B) revealed the classic H sign of a sacral insufficiency fracture in addition to an active L4 compression fracture. As a planning step, preoperative pelvic CT showed sclerotic changes with cortical disruption bilaterally, confirming the sacral insufficiency fractures (Fig 1C). In addition to L4 vertebroplasty, she consented to attempt the sacroplasty alternative.

limited in its usefulness for position confirmation. Using the Parallax injection system (Ezflow Cement Delivery System, Parallax Medical Inc., Scotts Valley, CA), we injected the polymethylmethacrylate cement and barium powder mixture under fluoroscopic monitoring (Fig 1D and E). The overlapping bony pelvis obscured sacral visualization, complicating our assessment of whether the injected cement was contained within the sacrum. A postoperative pelvic CT scan showed cement within the bilateral superior sacral ala, in the vicinity of the fracture lines (Fig 1F). Postoperative instructions included remaining in a supine position for 4 hours, with discharge home afterward.

Pain relief was immediately evident that night, with virtually complete relief of symptoms. At a 1-month follow-up clinical visit, she remained pain free, had regained her independence from a wheelchair and walker, and no longer needed analgesic medication. A follow-up pelvic radiograph showed the cement within the superior sacrum (Fig 1G). By telephone report 16 weeks after the procedure, the patient continued to be pain free with no recurrence of lower back complaints despite two minor falls at home in the interim.

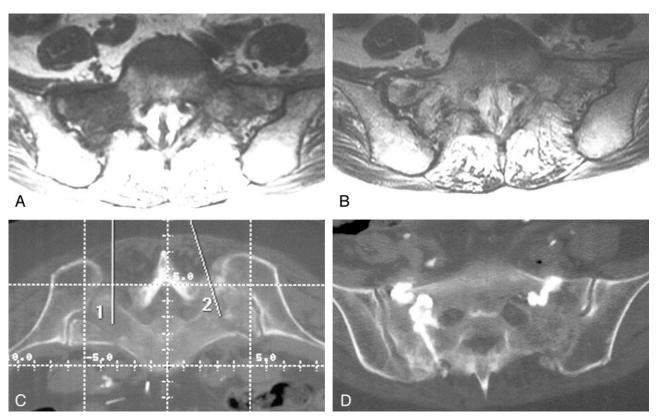
Fig. 3. Case 3, a 74-year-old woman with sacral insufficiency fracture.

A and B, Preoperative sacral MR images show low-T1 (A[TR/TE, 450/14]) and high-T2 (B[4000/99]) signal intensity, consistent with the edema from a sacral insufficiency fracture.

- C, Pelvic CT scan illustrates the two intended needle paths, simplifying needle placement during sacroplasty.
- D, Postoperative CT confirms cement location.

MR images obtained in a 74-year-old bedridden woman with severe lower back pain (Fig 3A and B) revealed edema within the sacrum, consistent with a sacral insufficiency fracture. Sacroplasty was performed in the CT suite, which greatly simplified needle placement (Fig 3C). Needle placement in the sacrum was performed by using CT guidance. A portable C-arm fluoroscope was brought to the CT suite and used to

monitor cement injection. Postoperative CT confirmed the sacral cement placement (Fig 3D). The patient's pain greatly diminished after the procedure, but she was lost to follow-up.
