Case Report

Black Holes on MR Images of the Brain of Patients with Björk-Shiley Heart Valves: Additional Observation in Three Cases

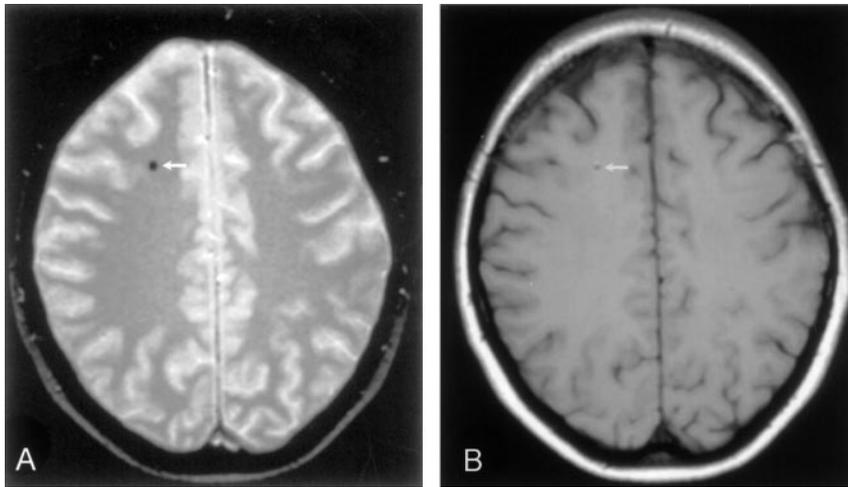
FIG 1. Patient 2.

A, Axial view T2*-weighted gradient-echo image (710/27.6/2 [TR/TE/number of excitations]) shows a black hole (arrow). Repeat images obtained after 1 year appeared unchanged, with no increase in number or size of black holes (not shown).

B, Corresponding axial view T2-weighted spin-echo image (1380/60/2) shows the same black hole with a typical white halo (arrow).

The substances that could be responsible for these susceptibility artifacts can be divided approximately into four different groups: air, calcium, microhemorrhages, and foreign metallic particles. Air can be ruled out because of expected resolution over time, which we did not observe on the second set of images obtained for patient 2 after 1 year. As for calcium deposits, these have slightly distinct appearances on MR images and lack the white halo, which was clearly visible on the T2-weighted spin-echo sequence of pa-

tient 2 (Fig 1B). In addition, the blooming of signal intensity loss on the T2*-weighted gradient-echo sequence is not observed with calcium deposits.

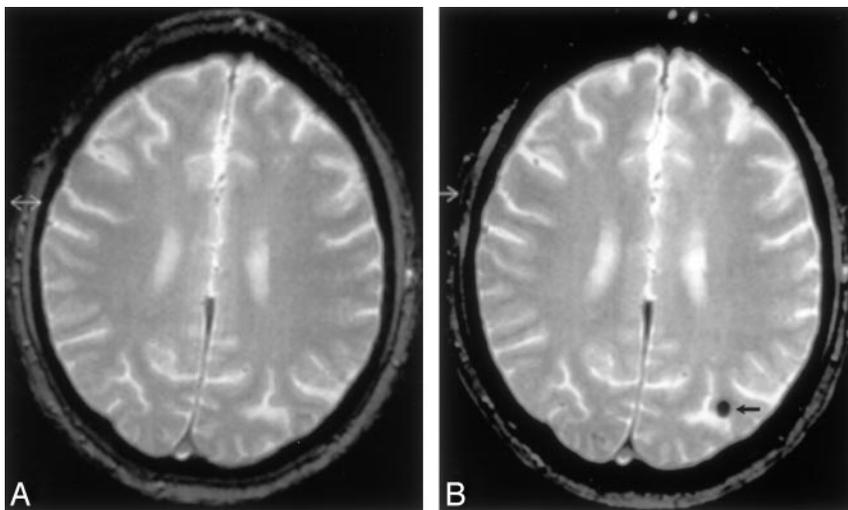
FIG 2. Patient 3.

A, Axial view T2*-weighted gradient-echo image (710/27.6/2), obtained 1 week before double valve replacement, shows no apparent abnormalities.

B, Axial view T2*-weighted gradient-echo image (710/27.6/2), obtained 5 months after successful double valve replacement, shows one of the two large black holes (arrow).

Interestingly enough, the images of patient 3 showed artifacts after the Björk-Shiley convexo-concave valve explantation and not before. When valve wear or damage is considered for this patient, one would expect that the "exposure time" of the valve to the circulation was sufficient to cause some artifacts. In addition, no cracks or fractures were discovered with scanning electron microscopy research after valve removal, although common valve wear was obvious. Based on the postoperative changes seen on the MR images, it seems that surgery played a more important role in the formation of these artifacts. This could also be the case for the first two patients for whom we did not have MR images of the brain before explantation. If intensive cardiac surgery were to induce these artifacts, however (ie, by means of surgical instrumentation or cardiopulmonary bypass machines), one would expect to observe it more frequently in daily practice. This may be explained in part by considering that patients with prosthetic heart valves often are unjustly withheld from MR imaging investigation because of fear of valve failure being induced by the magnetic field (14). Moody et al (15) have reported extensively on microembolic phenomena associated with cardiopulmonary bypass, combining clinical presentations and histochemical staining. Unfortunately, in our cases, no pathologic or histochemical evidence is available. In general, detrimental effects on the brain after cardiopulmonary bypass
