Compatibility of cervical spine braces with MR imaging: a study of nine nonferrous devices.

AJNR Am J Neuroradiol 1990, 11 (2) 385-390

Compatibility of Cervical Spine Braces with MR Imaging: A Study of Nine Nonferrous Devices

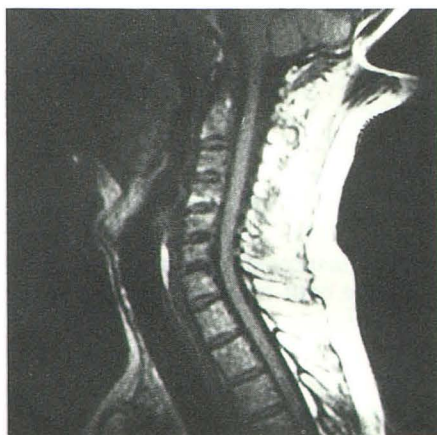
Fig. 3.—T1-weighted cervical spine MR image obtained with the patient wearing a modified Guilford cervical orthosis. Minimal distortion of the posterior cervical soft tissues below the occiput is presumably due to an electrical loop formed by the mandibular and occipital shells.

A T1-weighted cervical spine MR examination on a volunteer fitted with the pink Philadelphia collar with plastic fasteners demonstrated no metal blowout artifacts in the images. Similar results were obtained with the volunteer wearing the modified Guilford cervical orthosis. Although some distortion of the superficial soft tissues in the lower occipital area was present, presumably due to the loop formed by the occipital and mandibular shells, there was no distortion in the region of interest (Fig. 3). Scanning of the cervical spine and the brain in a volunteer fitted with the standard or the prepro-

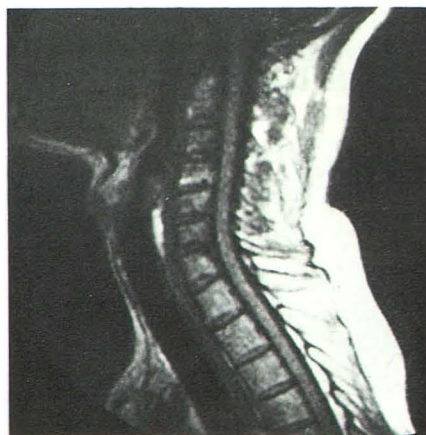
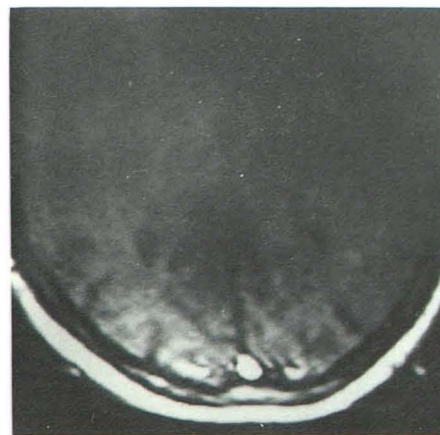
Fig. 4.—A and B, T1-weighted cervical spine (A) and brain (B) MR images obtained with a standard Bremer halo cervical orthosis in place. Cut-off in the anterior aspect of the brain image is due to eddy currents induced within the halo crown by the magnetic field gradients, which alter frequency and phase-encoded spatial information.

duction MR-compatible Bremer halo crown and vest or the standard or the modified PMT cervical orthosis was performed by placing the flat lumbar spine coil between the posterior aluminum rods of the orthosis. The standard Bremer device gave a satisfactory T1-weighted cervical spine examination (Fig. 4A), but the brain examination produced unacceptable images distorted by image cut-off ("loop effect") (Fig. 4B). T1, T2, and gradient-echo images of the volunteer wearing the preproduction MR-compatible Bremer halo system were satisfactory for the cervical spine examination (Figs. 5A–5C). Signal fall-off rendered the T1 brain images suboptimal. However, all areas of the brain could be seen by adjusting level and window settings (Fig. 5D). Brain images obtained with the body coil as the receiver were of diagnostic quality despite some loss in the signal-to-noise ratio and the spatial resolution (Fig. 5E). The standard PMT cervical orthosis introduced no artifacts in the cervical spine images (Fig. 6). T1, T2, and gradient-echo cervical spine and T1-weighted brain scans obtained with the PMT device containing graphite-carbon composite components were acceptable (Figs. 7A–7C), though brain images obtained with the surface coil were again limited by signal fall-off (Fig. 7D).
