Compatibility of Cervical Spine Braces with MR Imaging: A Study of Nine Nonferrous Devices

David A. Clayman¹
 Marcia E. Murakami
 Frederick S. Vines

AJNR 11:385-390, March/April 1990

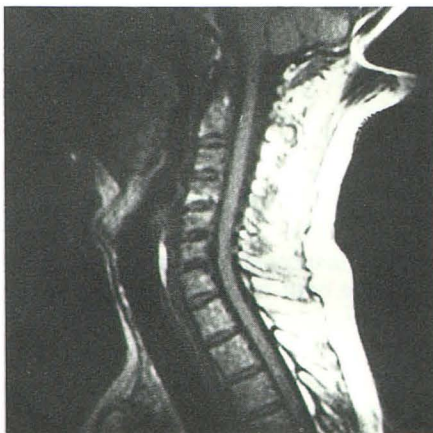
Fig. 3.—T1-weighted cervical spine MR image obtained with the patient wearing a modified Guilford cervical orthosis. Minimal distortion of the posterior cervical soft tissues below the occiput is presumably due to an electrical loop formed by the mandibular and occipital shells.

A T1-weighted cervical spine MR examination on a volunteer fitted with the pink Philadelphia collar with plastic fasteners demonstrated no metal blowout artifacts in the images. Similar results were obtained with the volunteer wearing the modified Guilford cervical orthosis. Although some distortion of the superficial soft tissues in the lower occipital area was present, presumably due to the loop formed by the occipital and mandibular shells, there was no distortion in the region of interest (Fig. 3). Scanning of the cervical spine and the brain in a volunteer fitted with the standard or the prepro-

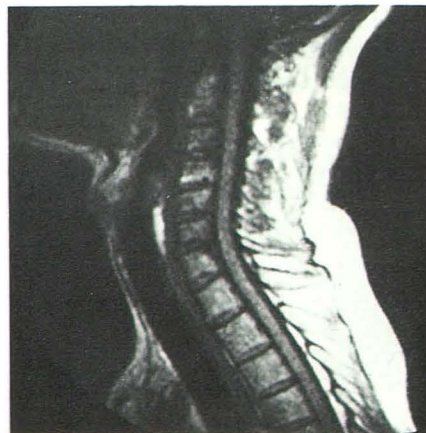
Fig. 4.—A and B, T1-weighted cervical spine (A) and brain (B) MR images obtained with a standard Bremer halo cervical orthosis in place. Cut-off in the anterior aspect of the brain image is due to eddy currents induced within the halo crown by the magnetic field gradients, which alter frequency and phase-encoded spatial information.

duction MR-compatible Bremer halo crown and vest or the standard or the modified PMT cervical orthosis was performed by placing the flat lumbar spine coil between the posterior aluminum rods of the orthosis. The standard Bremer device gave a satisfactory T1-weighted cervical spine examination (Fig. 4A), but the brain examination produced unacceptable images distorted by image cut-off ("loop effect") (Fig. 4B). T1, T2, and gradient-echo images of the volunteer wearing the preproduction MR-compatible Bremer halo system were satisfactory for the cervical spine examination (Figs. 5A–5C). Signal fall-off rendered the T1 brain images suboptimal. However, all areas of the brain could be seen by adjusting level and window settings (Fig. 5D). Brain images obtained with the body coil as the receiver were of diagnostic quality despite some loss in the signal-to-noise ratio and the spatial resolution (Fig. 5E). The standard PMT cervical orthosis introduced no artifacts in the cervical spine images (Fig. 6). T1, T2, and gradient-echo cervical spine and T1-weighted brain scans obtained with the PMT device containing graphite-carbon composite components were acceptable (Figs. 7A–7C), though brain images obtained with the surface coil were again limited by signal fall-off (Fig. 7D).

netic fields sufficiently distort the main magnetic field to degrade the MR images [11]. One device tested, the standard Bremer halo crown and vest, clearly possessed this problem with brain imaging. Interrupting the electrical loop in the halo
