**MRI Head Coil Malfunction Producing
Artifacts Mimicking Malformation of
Cortical Development in Pediatric Epilepsy
Work-Up**

N. Kashani, N. Khan, J.M. Ospel and X.-C. Wei

AJNR Am J Neuroradiol 2020, 41 (8) 1538-1540

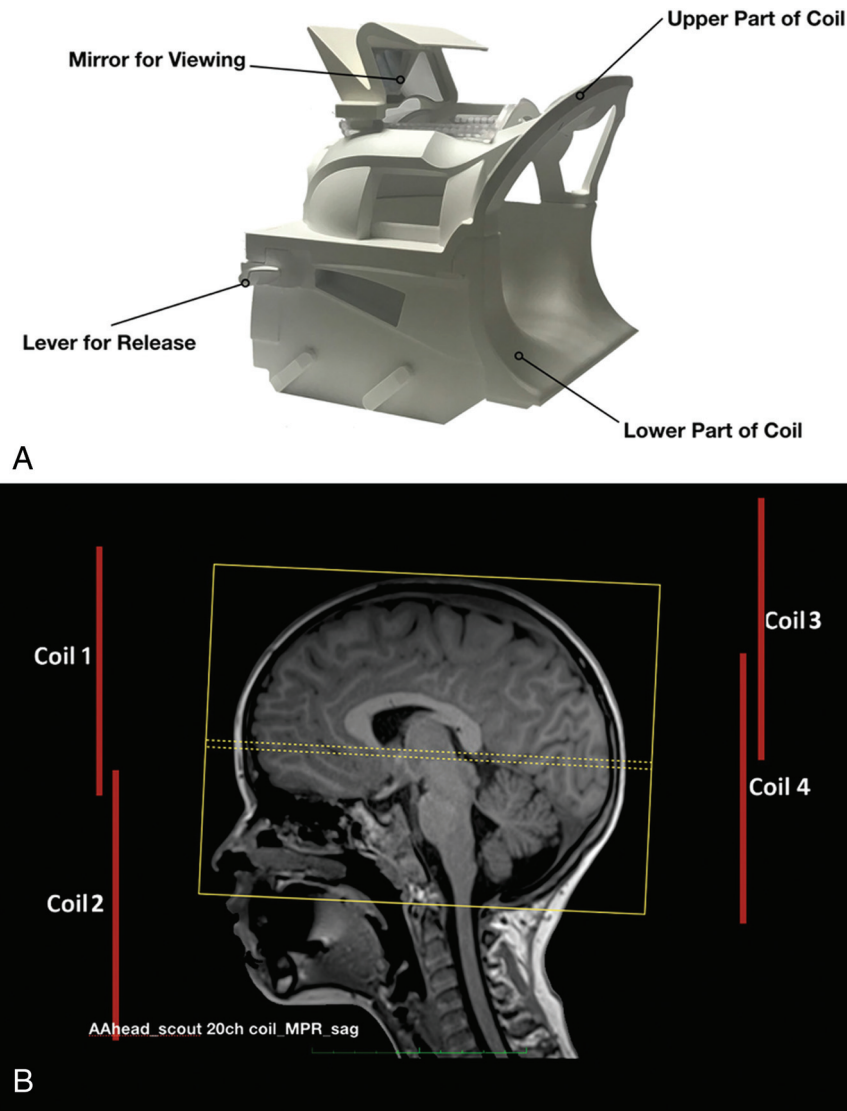
Evaluation of the morphology of the cerebral cortex in pediatric neuroimaging is crucial to rule out a malformation of cortical development. The cortical abnormalities can be subtle, and utilization of multiple-phased array head coils is beneficial.¹ Modern MR imaging scanners often use phased array coils that consist of multiple detectors, which allow images of high quality.^{2,3} These coil elements are placed around the body parts being imaged (Fig 1A). They are usually divided into groups that are, in turn, connected to the system by plugging into the scanner.³ The operators can view the locations and status of each group of coil elements on the computer monitors (Fig 1B).

FIG 1. Picture of a typical multichannel MR head coil (A) shows the positions of the multiple coil elements. A modified screenshot from the operator console of the system (B) shows indicators of the positions of the 4 groups of a 20-channel head coil. Red bars show the position of the individual groups of head coil elements. The coils 1 and 2 are anterior coils, while the coils 3 and 4 are posterior coils.
