A Technique to Circumvent Subcutaneous Cement Tracts during Percutaneous Vertebroplasty

Timothy J. Kaufmann, John T. Wald and David F. Kallmes

AJNR Am J Neuroradiol 2004, 25 (9) 1595-1596 http://www.ajnr.org/content/25/9/1595

- Technical Note

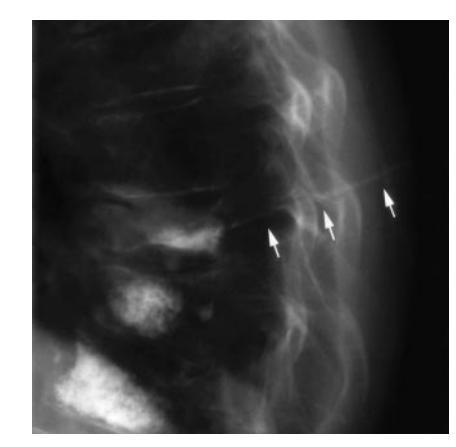
Fig 1. Cement is seen in the needle tract of the subcutaneous tissues of the lower thorax, extending dorsally from the T9 vertebral body cement deposition site (*arrows*).

We typically employ a moderately viscous cement mixture of powdered Codman cranioplastic polymethylmethacrylate, gentamicin, barium (Parallax Medical, Scotts Valley, CA), and liquid Codman cranioplastic methylmethacrylate monomer in our PV cases (2). On withdrawal of the 13-gauge Osteo-Site needle (Cook Inc., Bloomington, IN) from the T9 vertebra, the cylindrical column of partially solidified cement that was yet in the needle remained in the needle tract from the site of instillation in the vertebral body, through the left pedicle, and into the subcutaneous tissues of the lower thorax, as depicted radiographically (Fig 1).

The patient experienced persistent pain and tenderness at the site of this subcutaneous cement deposition, particularly when sitting on backed chairs. Two months after the procedure, the patient underwent surgical removal of 2.5 cm of the superficial portion of the subcutaneous cement. The surgery was effective in alleviating her pain.

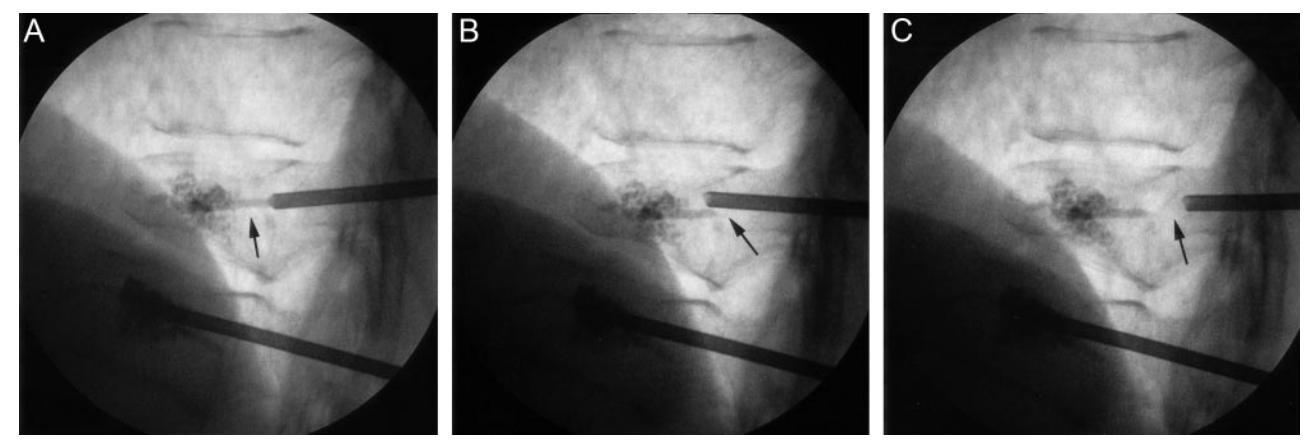
Fig 2. Deposition of a subneutaneous cement tract is averted.

A, Cement column, visualized in the posterior T11 vertebral body (arrow) as needle withdrawal is first begun.

B, The cement column inside the needle is broken at the tip of the needle (*arrow*) by pulling the needle hub inferiorly and advancing the tip of the needle toward the superior endplate.

C, The needle can then be withdrawn without further cement deposition in the needle tract (arrow).

We used 11-gauge Osteo-Site needles and the cement mixture described in case 1. Following cement instillation through the left T11 pedicle, we noticed that as the needle was being withdrawn with its tip still within the posterior aspect of the vertebral body, the core of partially solidified cement within the needle was being deposited in the needle tract (Fig 2A). Despite multiple attempts at breaking the cement core by rotating the needle and advancing and withdrawing the needle, the column of cement remained unbroken.

To prevent the deposition of a subcutaneous cement tract, the needle tip was then redirected superiorly and advanced toward the superior endplate, which cut completely through the column of cement (Fig 2B). This maneuver disconnected the cement deposited in the vertebral body from that which remained in the needle and allowed the needle to be subsequently withdrawn completely without depositing cement within the needle tract (Fig 2C).

We describe a simple maneuver in case 2 that can avert this complication. This technique may be employed during needle removal as soon as it is recognized that cement deposition is occurring in the needle tract. As needle position within the vertebral body may differ in other cases, the needle may be advanced forward across the cement column to cut it in any direction that is safe, with care taken to remain within the vertebral body and to avoid transgression of a vertebral endplate. The need for this technique should not be frequent, but we have used it successfully in two patients since case 1. There are potential limitations to this technique. It would be theoretically possible to fracture the pedicle if extreme repositioning of the needle trajectory were needed to cut through the cement tract. Risk of this complication might be mitigated in soft, osteoporotic bone. Further, redirection and advancement of the needle might injure adjacent tissue such as the vertebral endplate, which should be avoided.
