## **Balloon-Related Complications and Technical Failures in Kyphoplasty for Vertebral Fractures**

*AJNR Am J Neuroradiol* 2010, 31 (1) 175-179

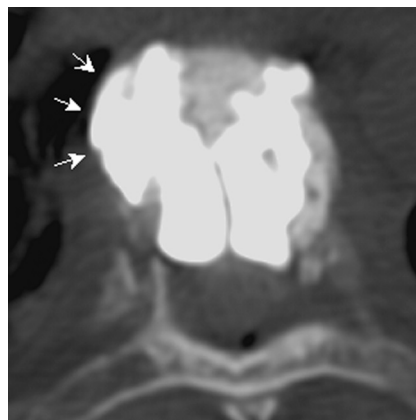
**Fig 1.** Thoracic balloon kyphoplasty (BKP) for vertebral fracture due to multiple myelomas. Note anterolateral cement leakage due to a focal cortical fracture caused by balloon inflation (arrows).

First, we observed cortical or endplate fracture by balloon expansion in 4 vertebrae of 4 patients (mean age, 72 years; range, 62–78 years): 3 with osteoporosis and 1 with a myeloma (Fig 1). In 1 female patient (78 years of age with a myeloma), endplate fracture by balloon expansion led to a procedural fracture of an adjacent vertebral body (Fig 2). Second, we found vertebral re-collapse after deflation in 4 vertebrae of 4 patients (2 men and 2 women; mean age, 67 years; range, 50–82 years; mean re-collapse angle, 5°; Fig 3). Re-collapse was not related to a low clinical success; 100% of patients with re-collapse showed improvement of pain after treatment. The technique of maximum fracture reduction, as described in "Materials and Methods," was used successfully in 2 of the 4 patients with vertebral fracture re-collapse after balloon deflation. Loss of local kyphosis reduction after balloon deflation was 4° and 9° for these 2 patients. The maximum fracture reduction technique restored the angle initially obtained. An analgesic effect was observed in both patients with no mortality or morbidity. Third, we observed balloon rupture during inflation in 5 vertebrae of 5 patients (2 men and 3 women;

If a cortical fracture occurs in the vertebral endplates, the inflated balloon can reach an adjacent vertebra when the intervertebral disk is thin and damage this adjacent vertebra. Four focal cortical fractures due to balloon expansion were observed in our study, and an adjacent vertebral fracture occurred procedurally due to expansion of the balloon through the vertebral endplate and the adjacent intervertebral disk. A predisposing factor for cortical fracture may be the presence of heterogeneous bone structure in a vertebra. This can lead to nonuniform balloon expansion during BKP and subsequent cortical fracture. Previously, we described a technique called “controlled segmental balloon kyphoplasty,” which allows controlled reduction of fractures in vertebrae with heterogeneous bone structure.<sup>5</sup> In case of nonuniform expansion of balloons during inflation, we use that technique to decrease the risk of cortical fracture during inflation.

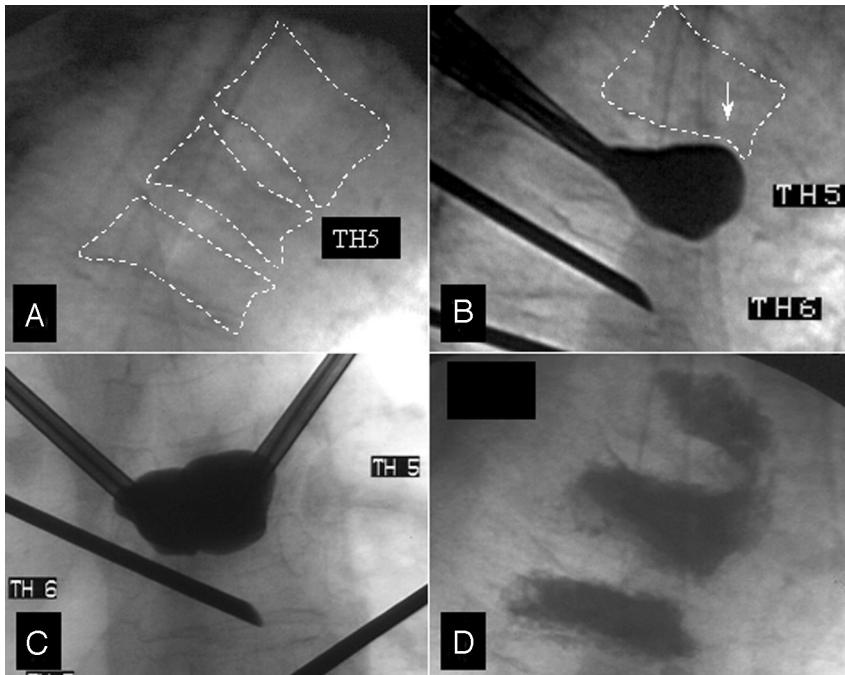
**Fig 2.** A, Patient with multiple vertebral fractures due to multiple myelomas. Lateral view of T4, T5, and T6 before treatment. B and C, Superior endplate fracture of T5 during balloon inflation responsible for inferior endplate fracture of T4 (arrow) during the kyphoplasty procedure at T5, lateral (B) and anteroposterior views (C). D, Final lateral view after cement injection. T4 and T6 vertebroplasty was performed at the same time.

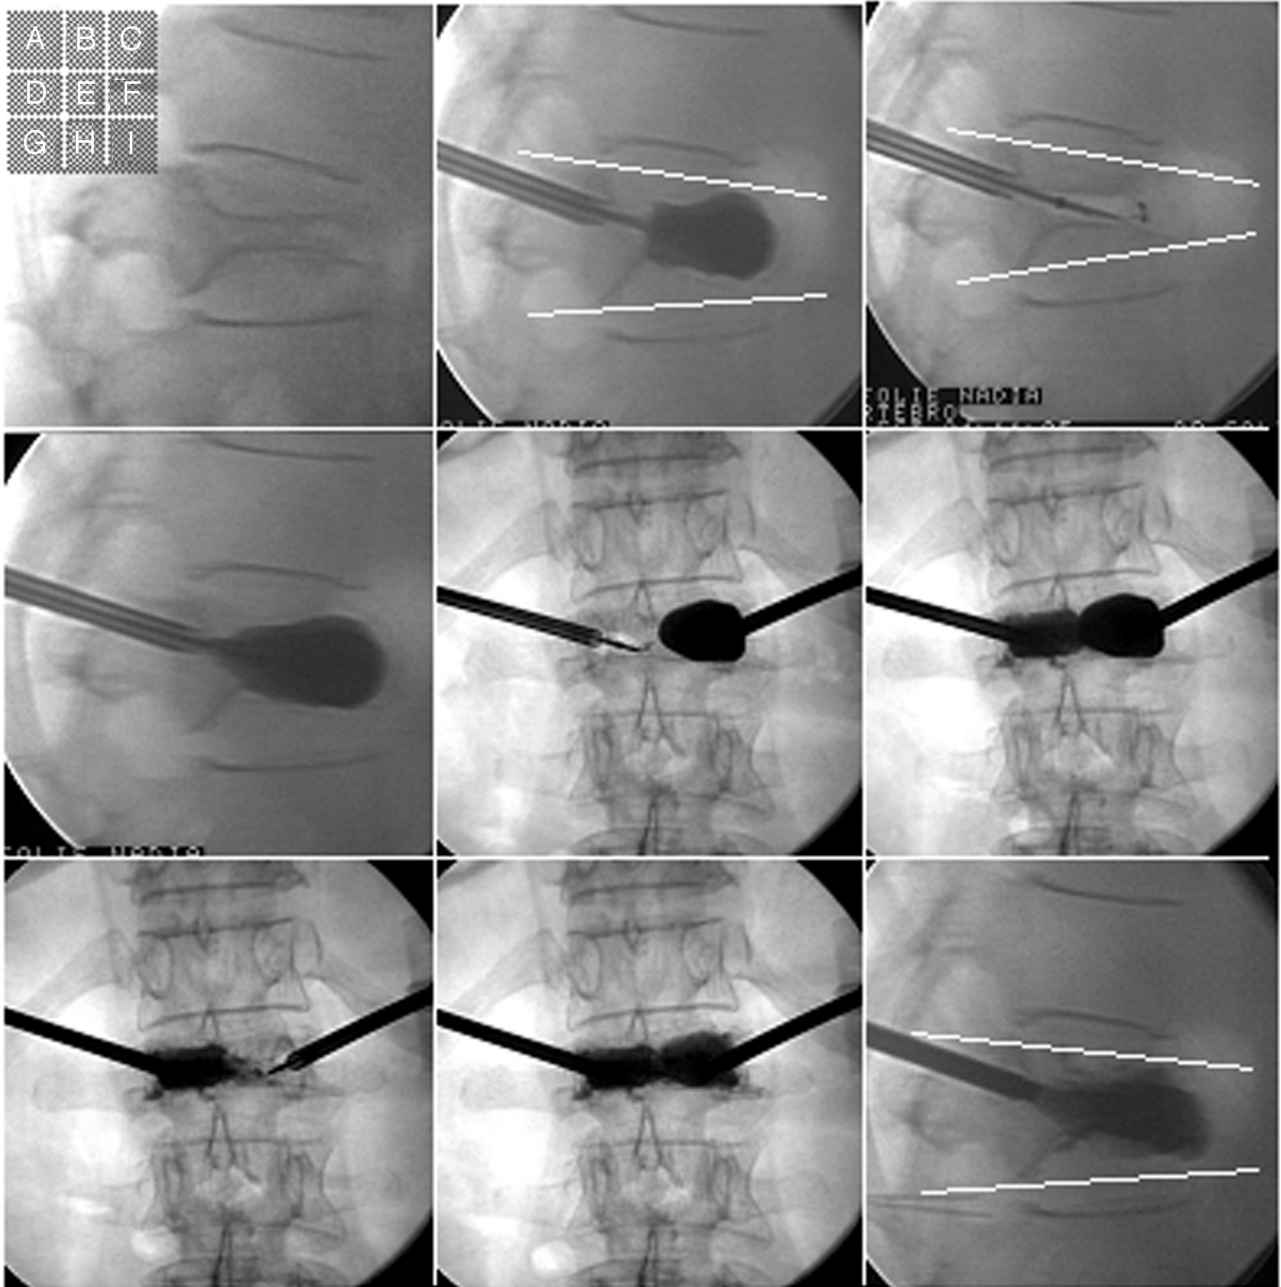
**Fig 3.** A, Maximal fracture reduction technique for a patient with L1 vertebral fracture due to osteoporosis. A–D, and I, Lateral view. E–G, and H, Frontal view. B, Initial balloon inflation leads to partial kyphosis correction (local kyphosis angle = 9°). C, Fracture reduction loss after balloon deflation (local kyphosis angle = 18°). D, Re-inflation of the 2 balloons to restore maximum fracture reduction. E and F, Deflation of only 1 balloon (E) and cement injection in the same side (F). G and H, After polymethylmethacrylate polymerization, deflation of the second balloon (G) and cement injection on the same side (H). I, Final view showing maintenance of the initial fracture reduction (local kyphosis angle = 9°).

In case of re-collapse of the vertebra after balloon deflation, the BKP technique was modified to avoid loss of fracture reduction after balloon deflation. The BKP technique was begun as usual, and the balloons were inflated to reduce the vertebral fracture. When a loss of fracture reduction was observed after deflating the balloons, as opposed to the conventional technique earlier described in "Materials and Methods," the 2 balloons were re-inflated to the same volume and pressure. Only 1 balloon was then deflated and removed instead of the 2 balloons. The balloon that was not deflated was designed to maintain the maximum fracture reduction initially obtained with the 2 balloons. Cement was injected at low pressure into the hemivertebra that did not contain the inflated balloon. After polymerization of the cement in this hemivertebra, the second balloon was deflated and removed and cement was injected into the ipsilateral hemivertebra. We called this technique "maximum fracture reduction."

Four patients in the present study developed visible loss of fracture reduction after balloon deflation. Two patients were successfully treated by the maximum fracture reduction tech-

nique. Although based on a small population, this adaptation of the kyphoplasty technique avoided loss of fracture reduction during the procedure. In this limited series, no case of anterior cement leakage or complication was observed with this technique. Kissing balloons, which can occur during inflation when the balloons are located too medially, must be avoided. Excessive contact between cement and balloon, when the cement is injected into 1 side of the vertebra while maintaining an inflated balloon in the other side, can result in damage to the balloon because PMMA polymerizes via an exothermic reaction,<sup>8-10</sup> releasing heat.

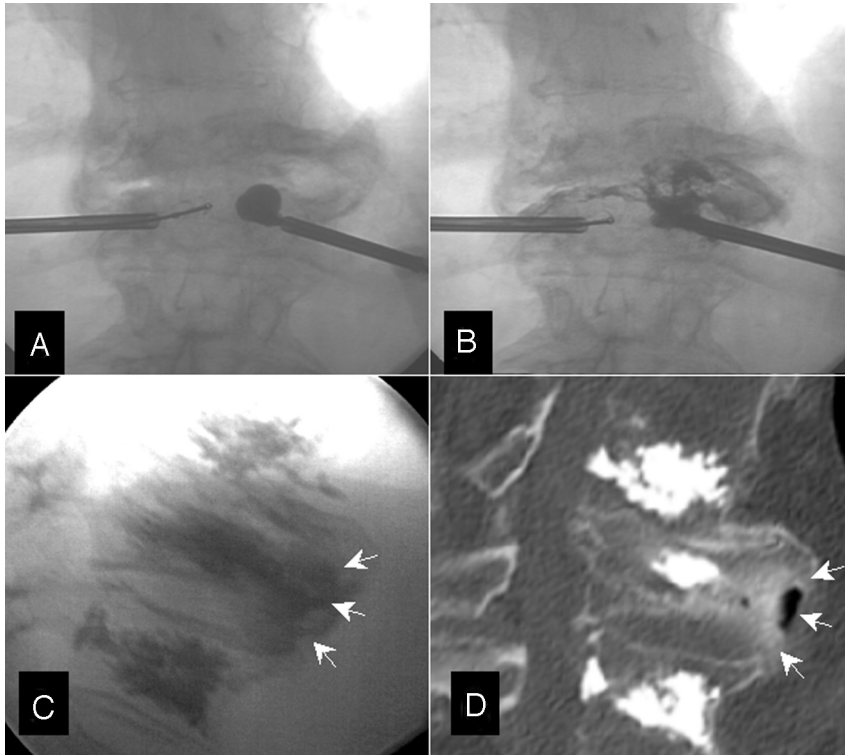
**Fig 4.** A, T12 BKP for vertebral fracture due to osteoporosis (frontal view). B and C, Balloon rupture responsible for anterior and lateral contrast leakage into the soft tissues (arrows). No arteriovenous leakage is seen. D, CT scan, final sagittal view showing anterior soft-tissue contrast leakage (arrows).

mean age, 62 years; range, 51–80 years): 2 with osteoporosis, 1 with trauma, 1 with lymphoma, and 1 with multiple myelomas (Fig 4).

When balloon rupture occurred, we observed that contrast agent did not leak into veins or arteries in any of the patients in this series but predominantly remained inside the vertebral body with minor contrast agent leakage through the fracture line into the paravertebral space. Finally, we found that 11 patients (21.5%) had transient hyperalgesia after the procedure (3 men; 8 women; mean age, 72 years; range, 52–82 years): 4 with myelomas, 4 with osteoporosis, 1 with trauma, 2 with metastases. In 9 of these patients, kyphoplasty alone was performed (9 vertebrae). In this selective subgroup, 3 patients (33%) experienced transient hyperalgesia.

Although in itself not necessarily a technical failure or complication, balloon rupture is an unwanted event during the procedure because it may lead, for example, to contrast leakage or procedural delay. Contrast agent did not leak into veins or arteries in any of the patients with balloon rupture in our study but, predominantly, remained inside or close to the vertebral body. This can probably be explained by the fact that in the case of balloon rupture, the pressure in the vertebra rapidly decreases and contrast agent is not pushed into paravertebral vessels. The cavity created before balloon rupture also probably provides a reservoir for contrast agent.

No symptomatic complication due to balloon rupture (ie, gas embolism) was observed in this series. In the technique of BKP, balloons must be purged of any trapped air before insertion to prevent gas embolism in the event of balloon rupture. Balloon rupture appears to be facilitated by sharp solid bone fragments. In our experience, the risk of balloon rupture can be decreased by very slowly increasing balloon inflation pressures, which appears to allow the shape of the balloon to adapt to the solid and sharp bony environment. An alternative or additional way to limit balloon rupture consists of using a curette to break bone bridges and contusive bone fragments before inflating the balloon.
