Normal Thickness and Appearance of the Prevertebral Soft Tissues on Multidetector CT

AJNR Am J Neuroradiol 2009, 30 (1) 136-141

ORIGINAL RESEARCH

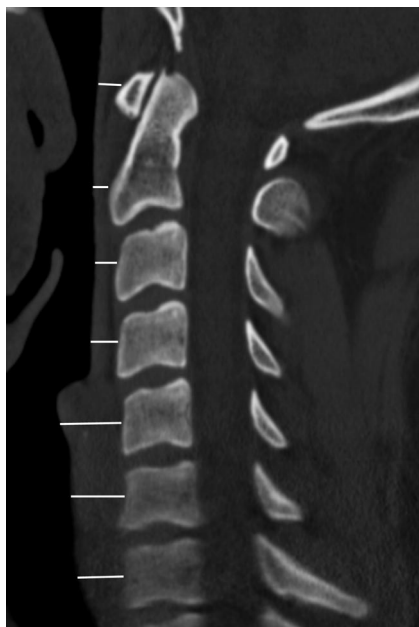
Fig 1. Midsagittal MDCT image of the cervical spine illustrating the method used to measure the thickness of the PVST.

The measurements were performed in the midline on sagittal reformatted images extending from the midanterior vertebral body to the closest point in the air column from C3 to C7 in the preset bone window. At C1 and C2, the measurements were performed from the cranio-caudal midpoint of the anterior arch of C1 and at the midpoint of the vertebral body of C2 (excluding the dens) to the closest point in the air column (Fig 1). The midline was determined by direct correlation with coronal reformatted images. Patients with scoliosis or positional rotation of the spine were analyzed after we obtained oblique sagittal reformatted images or by close correlation between the sagittal images and the coronal reformations to ensure the midline measurement. Measurements were recorded to the nearest half millimeter.

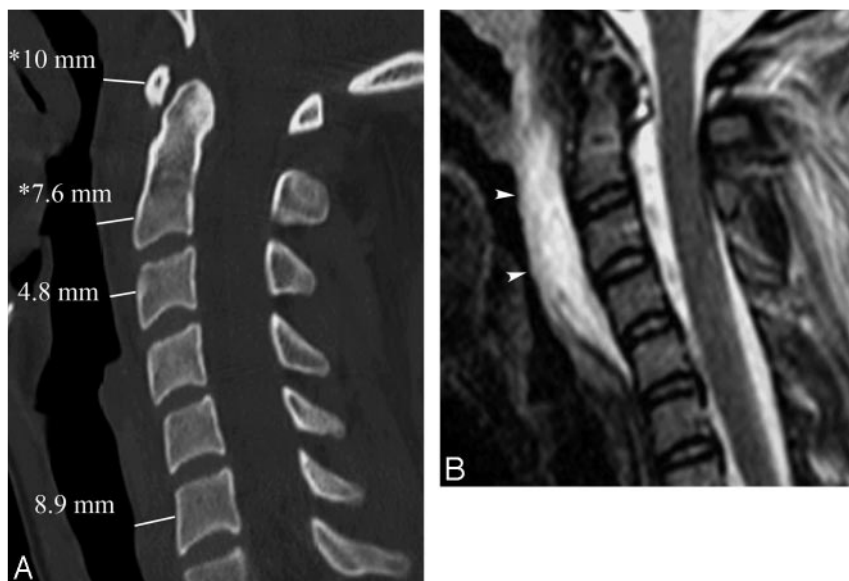
Fig 2. A 24-year-old patient after a motor vehicle crash with closed head injury; no fracture was identified in the cervical spine or craniocervical junction. *A*, Midsagittal MDCT image of the cervical spine demonstrates abnormal PVST thickening at C1 and C2 (asterisks). *B*, Correlation with midsagittal short τ inversion recovery MR image obtained the next day confirms the presence of extensive PVST edema and/or hematoma in this region (arrowheads).

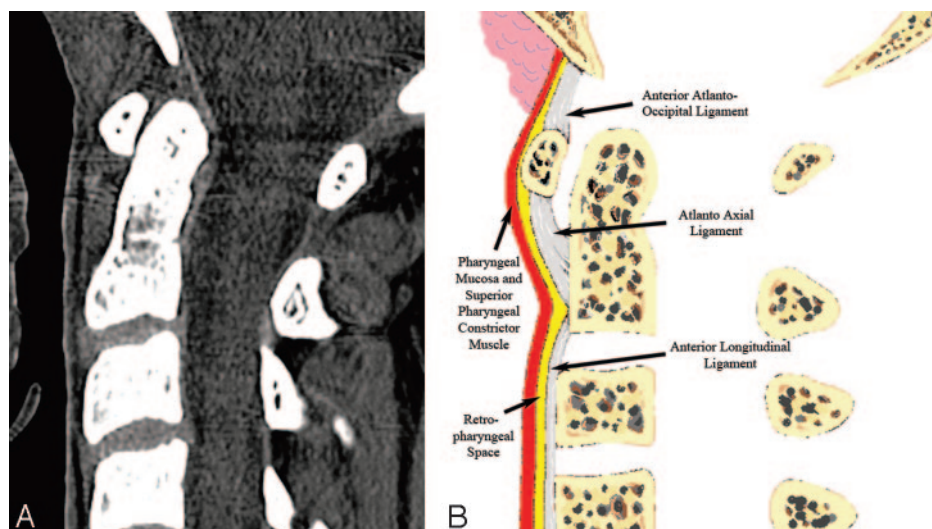
Fig 3. Normal appearance of the upper PVST on the midsagittal plane. *A*, MDCT image demonstrates 2 high-attenuation stripes separated by a central stripe of fat attenuation corresponding to the retropharyngeal/retroesophageal spaces. *B*, Diagram helps depict the normal anatomic planes of the PVST.

The normal appearance of the PVST as seen on midsagittal reformatted images of the cervical spine is of 3 thin stripes anterior and parallel to the spinal column (Fig 3). The most anterior stripe, adjacent to the airway, represents the pharyngeal mucosa and the pharyngeal constrictor muscles, accounting for its soft-tissue attenuation. It is consistently thin and extends from the skull base down to approximately the level of C4-C5, where it joins the esophagus.

The second stripe has fat attenuation and represents the areolar and adipose connective tissues of the retropharyngeal and retroesophageal spaces.²³ The retropharyngeal space is technically considered to extend from the base of the skull to the origin of the esophagus, where it continues inferiorly as the retroesophageal space. These 2 spaces are enclosed by the middle (visceral division) and deep (alar division) layers of the deep cervical fascia and contain a variable amount of lymph nodes superiorly.²⁴ The fat stripe normally lies in close proximity to the anterior surface of the vertebral bodies and displacement can help detect and localize injuries to cervical spine.²³ Variation in the thickness and conspicuity of this fat plane can be seen among individuals, but it is always present.²⁵ This could be explained by differences in a patient's body habitus, because patient weight has been shown to relate proportionally to the thickness of the PVST on radiographs.^{26,27} In some patients, this fat plane can be identified more easily on parasagittal images due to relative thinning of this fat attenuation stripe in the midsagittal plane.

The third stripe is of soft-tissue attenuation and is made of ligamentous structures. Below C2, it is composed of the anterior longitudinal ligament, which inserts superiorly in the anterior and inferior portion of the vertebral body of C2. Extending from the C2 vertebral body rostrally, the third stripe is formed by the anterior atlantoaxial and anterior atlanto-occipital ligaments, which extend from the vertebral body of C2 to the anterior arch of the atlas and from the anterior arch of the atlas to the clivus, respectively.¹

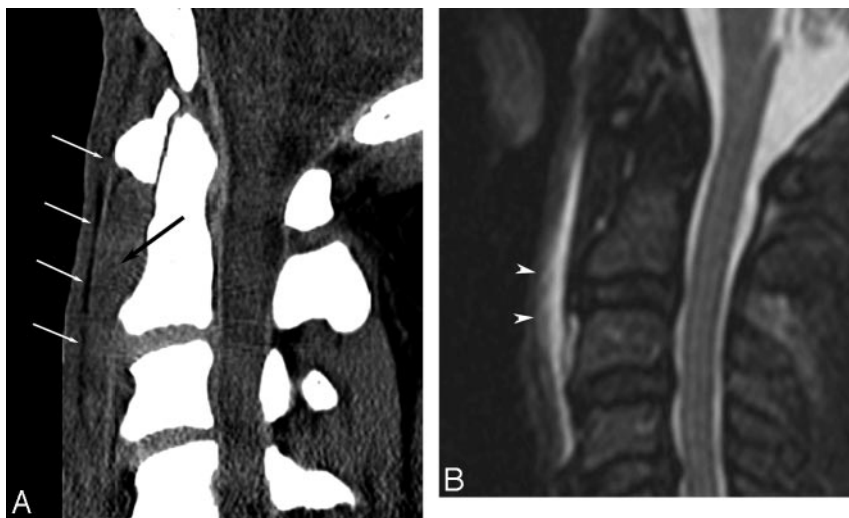
Fig 4. A 43-year-old patient after a motor vehicle crash with no osseous injury. *A*, Midsagittal MDCT image of the cervical spine demonstrates abnormal high attenuation (*black arrow*) anteriorly displacing the retropharyngeal fat plane (*white arrows*). *B*, Short τ inversion recovery MR image obtained the same day shows extensive PVST edema and/or hematoma in this region (*arrowheads*).

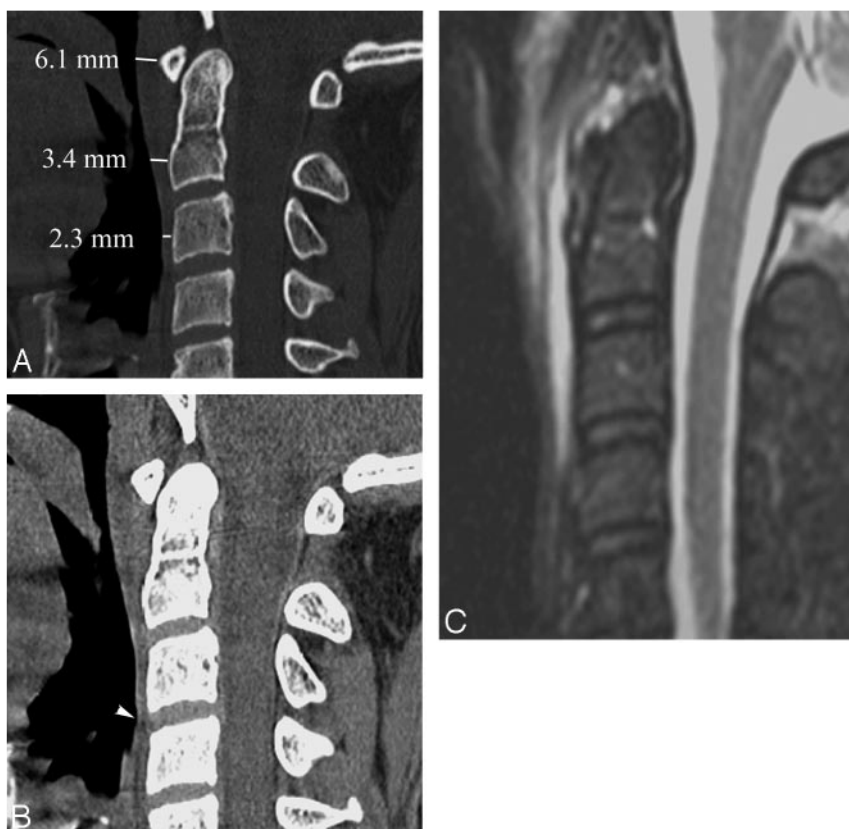
Fig 5. A 27-year-old patient after a motor vehicle crash with no osseous injury. *A*, Midsagittal MDCT image demonstrates normal PVST thickness by using normal values based on MDCT. *B*, Evaluation of the appearance of the PVST reveals subtle loss of the normal PVST fat plane above the inferior endplate of C3 (*arrowhead*). *C*, Correlation with short τ inversion recovery MR image obtained the same day confirms the presence of edema and/or hematoma of the PVST accounting for the MDCT image findings.

setting of normal PVST thickness (by using MDCT normal upper limit values) later confirmed to be secondary to the presence of PVST edema and/or hematoma on MR imaging (Fig 5). Therefore, in our opinion, evaluation of the thickness and appearance of the PVST should be performed in patients with a history of cervical spine trauma to avoid missing occult injuries that manifest as abnormality in the PVST.
