**Normal Thickness and Appearance of the
Prevertebral Soft Tissues on Multidetector
CT**

AJNR Am J Neuroradiol published online 11 November
2008

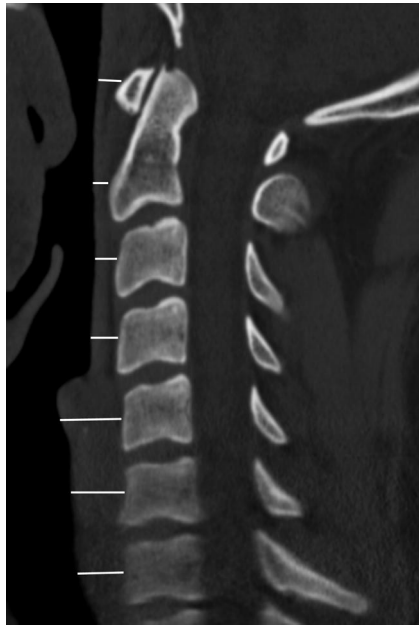
Fig 1. Midsagittal MDCT image of the cervical spine illustrating the method used to measure the thickness of the PVST.

The measurements were performed in the midline on sagittal reformatted images extending from the midanterior vertebral body to the closest point in the air column from C3 to C7 in the preset bone window. At C1 and C2, the measurements were performed from the craniocaudal midpoint of the anterior arch of C1 and at the midpoint of the vertebral body of C2 (excluding the dens) to the closest point in the air column (Fig 1). The midline was determined by direct correlation with coronal reformatted images. Patients with scoliosis or positional rotation of the spine were analyzed after we obtained oblique sagittal reformatted images or by close correlation between the sagittal images and the coronal reformations to ensure the midline measurement. Measurements were recorded to the nearest half millimeter.

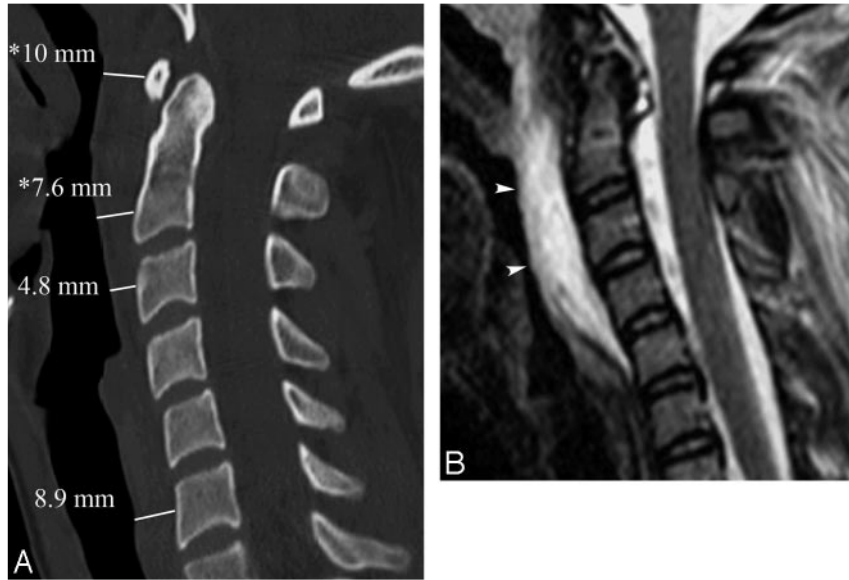
Fig 2. A 24-year-old patient after a motor vehicle crash with closed head injury; no fracture was identified in the cervical spine or craniocervical junction. A, Midsagittal MDCT image of the cervical spine demonstrates abnormal PVST thickening at C1 and C2 (asterisks). B, Correlation with midsagittal short τ inversion recovery MR image obtained the next day confirms the presence of extensive PVST edema and/or hematoma in this region (arrowheads).

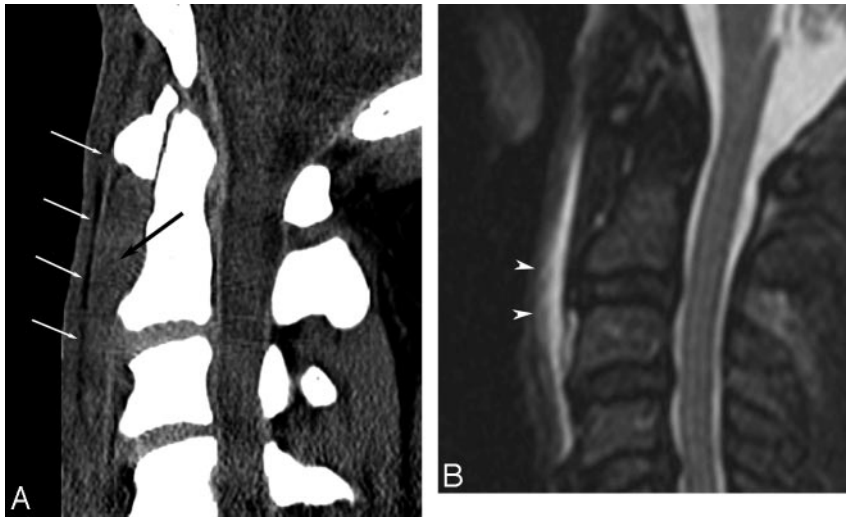
Fig 4. A 43-year-old patient after a motor vehicle crash with no osseous injury. *A*, Midsagittal MDCT image of the cervical spine demonstrates abnormal high attenuation (*black arrow*) anteriorly displacing the retropharyngeal fat plane (*white arrows*). *B*, Short τ inversion recovery MR image obtained the same day shows extensive PVST edema and/or hematoma in this region (*arrowheads*).

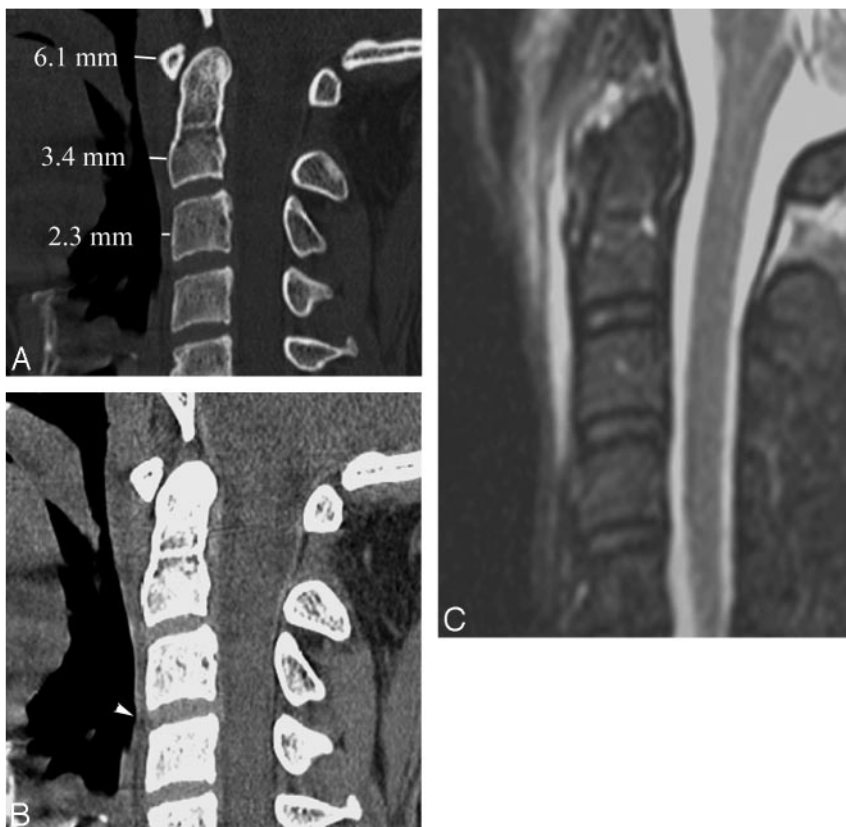
Fig 5. A 27-year-old patient after a motor vehicle crash with no osseous injury. *A*, Midsagittal MDCT image demonstrates normal PVST thickness by using normal values based on MDCT. *B*, Evaluation of the appearance of the PVST reveals subtle loss of the normal PVST fat plane above the inferior endplate of C3 (*arrowhead*). *C*, Correlation with short τ inversion recovery MR image obtained the same day confirms the presence of edema and/or hematoma of the PVST accounting for the MDCT image findings.

setting of normal PVST thickness (by using MDCT normal upper limit values) later confirmed to be secondary to the presence of PVST edema and/or hematoma on MR imaging (Fig 5). Therefore, in our opinion, evaluation of the thickness and appearance of the PVST should be performed in patients with a history of cervical spine trauma to avoid missing occult injuries that manifest as abnormality in the PVST.
