**Normal Thickness and Appearance of the
Prevertebral Soft Tissues on Multidetector
CT**

AJNR Am J Neuroradiol published online 11 November
2008

ORIGINAL
RESEARCHC.A. Rojas
D. Vermess
J.C. Bertozzi
J. Whitlow
C. Guidi
C.R. MartinezNormal Thickness and Appearance of the
Prevertebral Soft Tissues on Multidetector CT

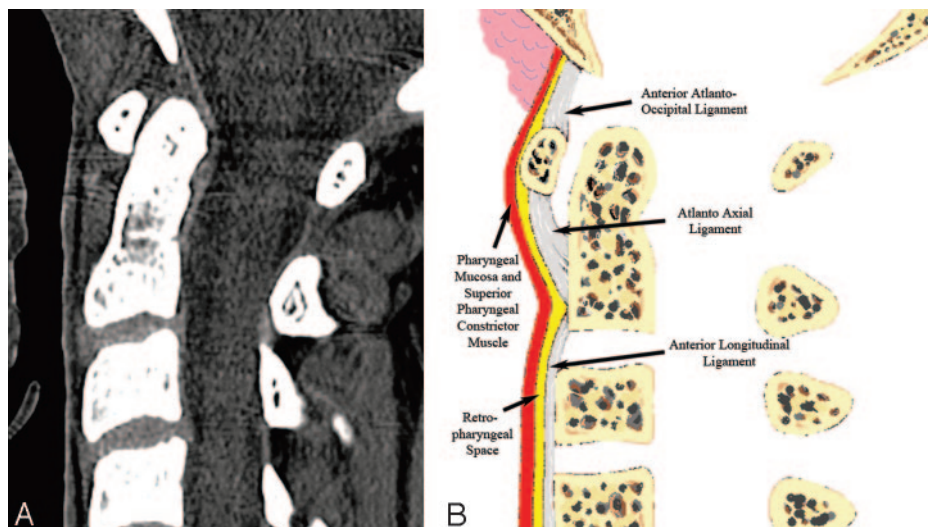
Fig 3. Normal appearance of the upper PVST on the midsagittal plane. A, MDCT image demonstrates 2 high-attenuation stripes separated by a central stripe of fat attenuation corresponding to the retropharyngeal/retroesophageal spaces. B, Diagram helps depict the normal anatomic planes of the PVST.

The normal appearance of the PVST as seen on midsagittal reformatted images of the cervical spine is of 3 thin stripes anterior and parallel to the spinal column (Fig 3). The most anterior stripe, adjacent to the airway, represents the pharyngeal mucosa and the pharyngeal constrictor muscles, accounting for its soft-tissue attenuation. It is consistently thin and extends from the skull base down to approximately the level of C4-C5, where it joins the esophagus.

The second stripe has fat attenuation and represents the areolar and adipose connective tissues of the retropharyngeal and retroesophageal spaces.²³ The retropharyngeal space is technically considered to extend from the base of the skull to the origin of the esophagus, where it continues inferiorly as the retroesophageal space. These 2 spaces are enclosed by the middle (visceral division) and deep (alar division) layers of the deep cervical fascia and contain a variable amount of lymph nodes superiorly.²⁴ The fat stripe normally lies in close proximity to the anterior surface of the vertebral bodies and displacement can help detect and localize injuries to cervical spine.²³ Variation in the thickness and conspicuity of this fat plane can be seen among individuals, but it is always present.²⁵ This could be explained by differences in a patient's body habitus, because patient weight has been shown to relate proportionally to the thickness of the PVST on radiographs.^{26,27} In some patients, this fat plane can be identified more easily on parasagittal images due to relative thinning of this fat attenuation stripe in the midsagittal plane.

The third stripe is of soft-tissue attenuation and is made of ligamentous structures. Below C2, it is composed of the anterior longitudinal ligament, which inserts superiorly in the anterior and inferior portion of the vertebral body of C2. Extending from the C2 vertebral body rostrally, the third stripe is formed by the anterior atlantoaxial and anterior atlanto-occipital ligaments, which extend from the vertebral body of C2 to the anterior arch of the atlas and from the anterior arch of the atlas to the clivus, respectively.¹
