Can a Stent Retriever Damage the JET 7 Reperfusion Catheter?

J. Pearly Ti, L. Yeo and G. Anil

AJNR Am J Neuroradiol published online 15 October 2020
<http://www.ajnr.org/content/early/2020/10/15/ajnr.A6804>

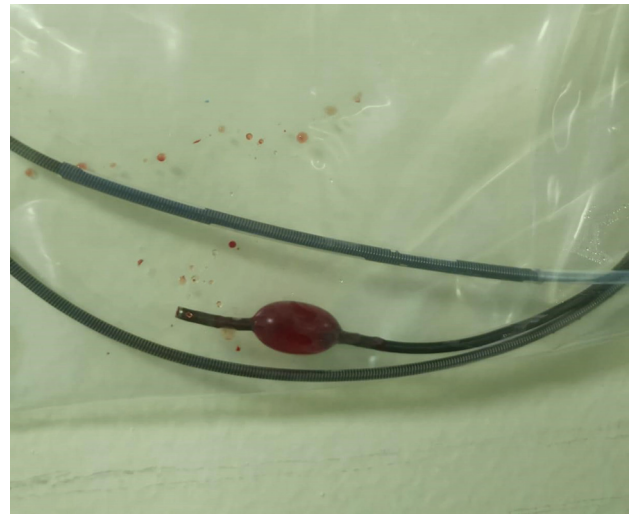
An 88-year-old woman presented with right M1 MCA occlusion and an NIHSS score of 12. Because she was outside the time window for intravenous thrombolysis, she was directly transferred to the angiosuite for mechanical thrombectomy. With the intention of using the direct aspiration first-pass technique, a JET 7 catheter was advanced over a 3MAX (Penumbra) and Transend 0.014-inch microcatheter-wire assembly, through a 6F Neuron MAX. However, it could not be navigated past the ledge of the ophthalmic artery origin. Hence, the procedure was converted to stent retriever thrombectomy. A 6 × 30 mm Solitaire-2 stent retriever (Medtronic) was deployed across the occlusion and allowed to integrate with the clot for 4 minutes. The Solitaire and the microcatheter were retrieved through the JET 7 with continuous suction using the ENGINE aspiration system. While we withdrew the stent retriever, the JET 7 spontaneously advanced beyond the ophthalmic segment of the ICA and wedged at the right M1-clot interface. Therefore, the operator decided to completely retrieve the Solitaire-microcatheter combination and left the JET 7 catheter in situ. The aspiration was continued for a further 3 minutes during which the aspiration tubing demonstrated slow continuous movement of blood toward the canister before removal of the JET 7. A subsequent angiogram showed TICI 3 reperfusion. When the JET 7 was flushed to check for clots *ex vivo*, we noted a similar ballooning (Fig 2) of the distal aspect of the catheter as described in case 1.

FIG 2. The damaged distal segment of the JET 7 thrombectomy catheter used in patient 2 has ballooned on flushing.

The exact mechanism of the damage to the catheter in these cases is not clearly understood. Pulling an unsheathed stent through the aspiration catheter could potentially harm its integrity due to the friction between the two. However, in the first case, even this mechanism is not plausible because the stent retriever was pushed out of the distal end of the catheter after removing both the catheter and stent together as a single assembly, ie, without pulling it through the JET 7. We did not encounter similar incidents with use

of the earlier generations of Penumbra aspiration catheters. However, in the last 5 years, there is an ongoing race to manufacture wider bore aspiration catheters with better flexibility and trackability, without increasing their outer diameters. Intuitively, this pursuit could entail a certain degree of compromise on their strength. Operators need to be cognizant of such trade-offs between the stoutness of a catheter against its flexibility and softness, while choosing them off the shelf. In the 2 cases reported here, the distal end of the catheter, beyond the site of ballooning, could have fragmented and embolized or been retained within the patient. Following this experience, after each pass, we closely examine these aspiration catheters for their integrity before re-introducing them into the cerebral circulation.
