# Vertebroplasty: Cement Leakage into the Disc Increases the Risk of New Fracture of Adjacent Vertebral Body

Edward P. Lin, Sven Ekholm, Akio Hiwatashi, and Per-Lennart Westesson

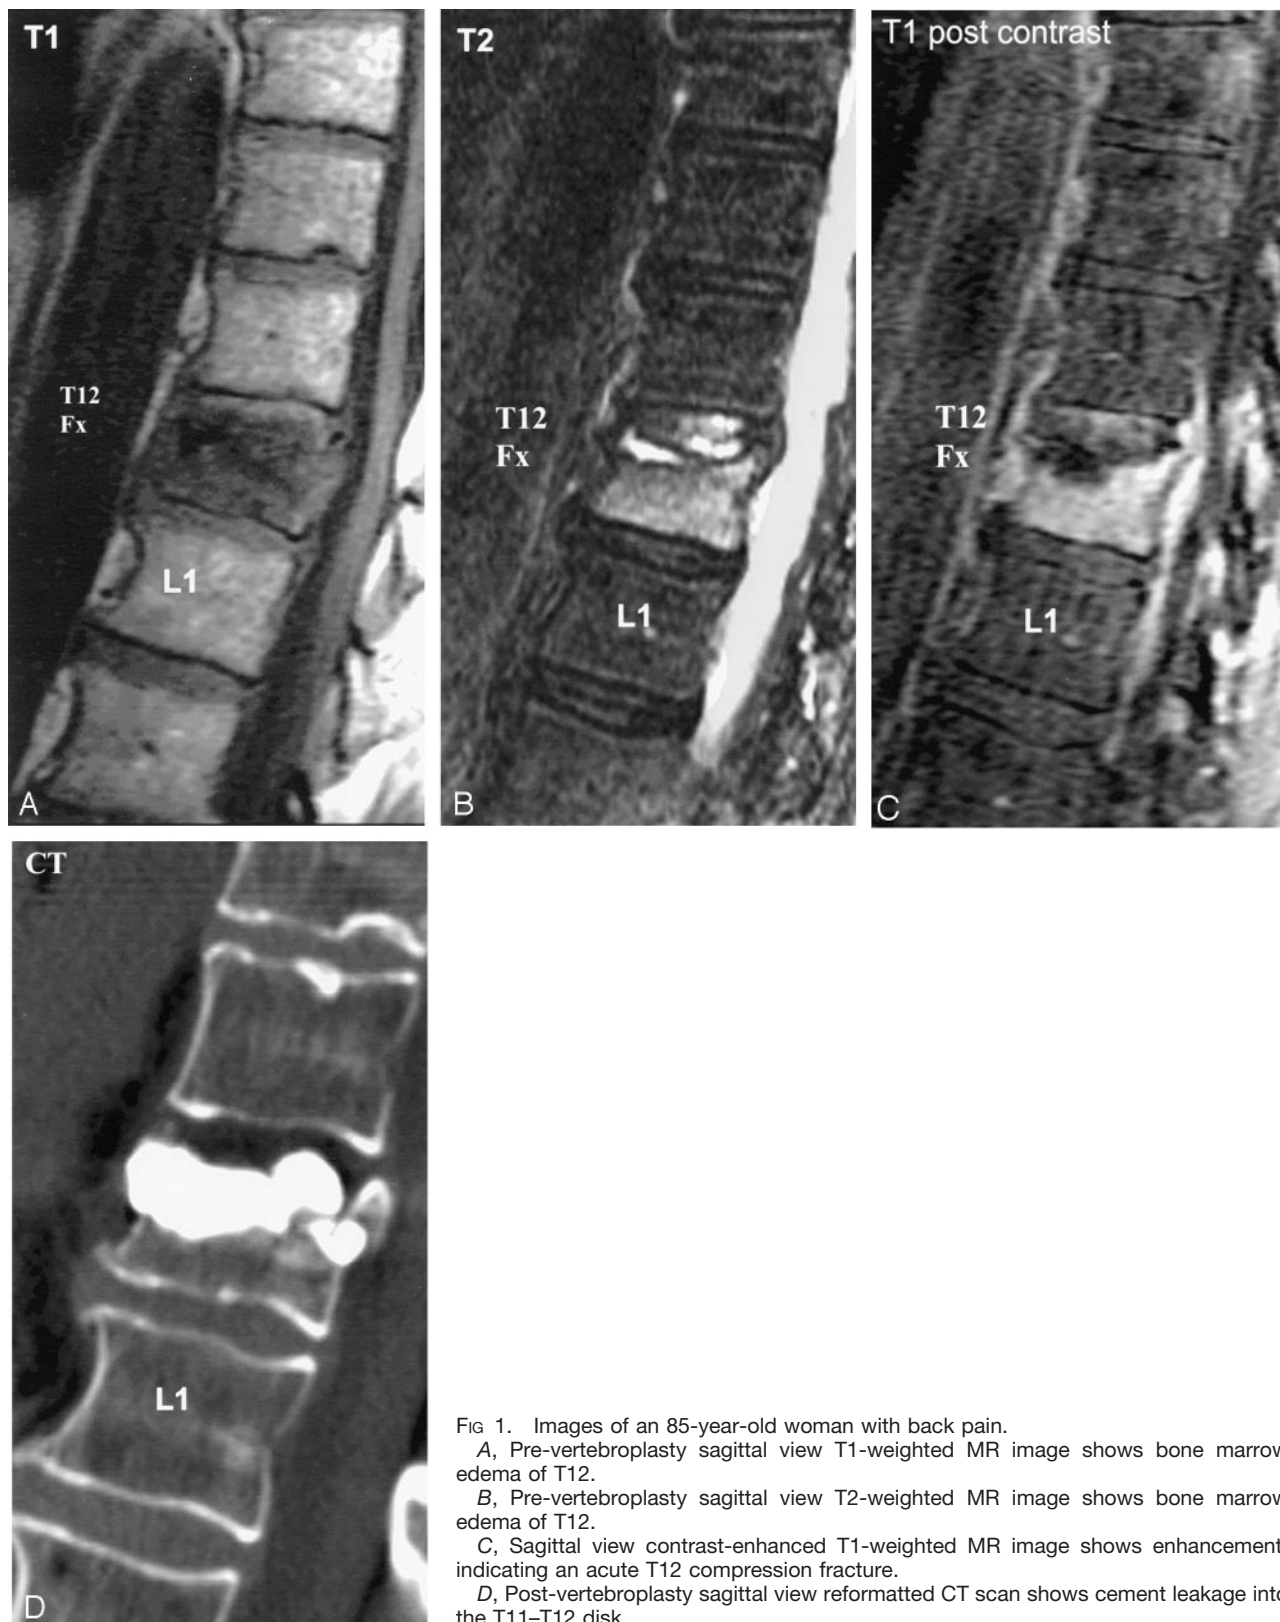
FIG 1. Images of an 85-year-old woman with back pain.

A, Pre-vertebroplasty sagittal view T1-weighted MR image shows bone marrow edema of T12.

B, Pre-vertebroplasty sagittal view T2-weighted MR image shows bone marrow edema of T12.

C, Sagittal view contrast-enhanced T1-weighted MR image shows enhancement, indicating an acute T12 compression fracture.

D, Post-vertebroplasty sagittal view reformatted CT scan shows cement leakage into the T11-T12 disk.

We identified new fractures in 14 of the 38 patients during the follow-up period. Ten patients had new fractures associated with cement leakage into the disk, and four patients had new fractures not associated with cement leakage into the disk (Table 2) (Figs 1 and 2). This difference was statistically significant ( $P = .018$ ).

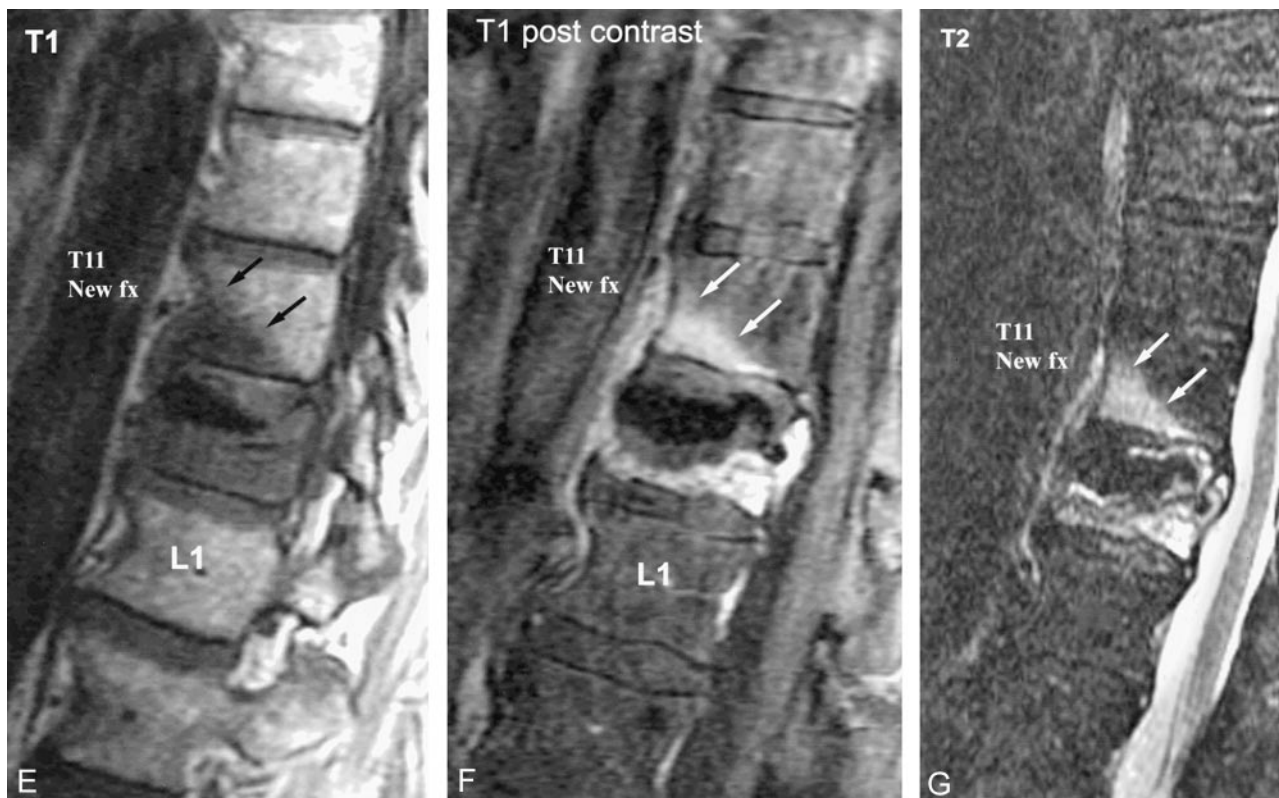
FIG. 1. Continued

E, Sagittal view T1-weighted MR image obtained 15 days later, when the patient returned with new pain, shows new bone marrow edema of T11.

F, Sagittal view T2-weighted MR image obtained 15 days later, when the patient returned with new pain, shows new bone marrow edema of T11.

G, Contrast-enhanced sagittal view T1-weighted MR image shows T11 enhancement, indicating a new acute T11 fracture.

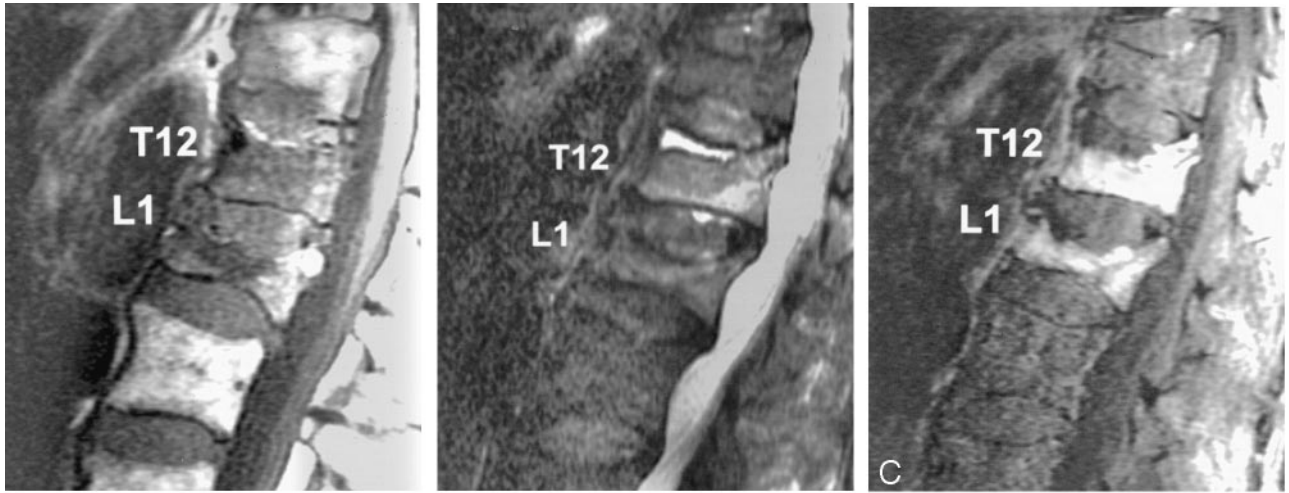
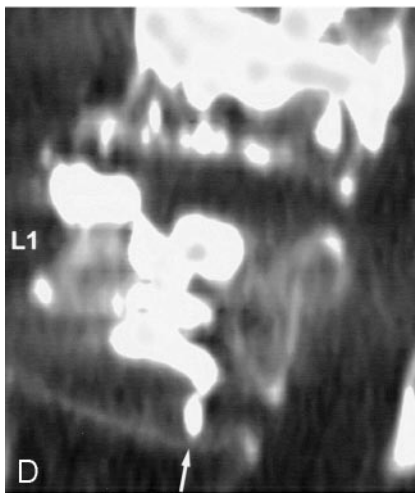
FIG 2. Images of a 79-year-old man with back pain.

A, Pre-vertebroplasty sagittal view T1-weighted MR image shows bone marrow edema of T12 and L1.

B, Pre-vertebroplasty sagittal view T2-weighted MR image shows bone marrow edema of T12 and L1.

C, Sagittal view contrast-enhanced T1-weighted MR image shows enhancement, indicating acute T12 and L1 compression fractures.

D, Post-vertebroplasty sagittal view reformatted CT scan shows cement leakage (arrow) into the L1-L2 disk. Of note, leakage of cement into the T11-T12 disk also occurred. However, T11 was treated with vertebroplasty at the same time as T12 and L1 therefore could not be evaluated for a possible new fracture.

We think that the mechanism for the new fractures is a combination of the underlying condition, mainly osteoporosis or neoplastic disease, and the hard cement in the disk. In eight of the 11 cases, the new fracture was immediately adjacent to the cement in the disk (Fig 2). The immediate adjacency of the cement and the new fracture is a strong indication that the hard cement results in an increased mechanical pressure, eventually causing a new fracture of the endplate in the adjacent vertebral body (Fig 2). The increased mechanical pressure is especially pertinent for patients who increase their daily physical activities as their back pain decreases after vertebroplasty, placing additional stress on the vertebral bodies.

For example, as shown in Figure 2, cement leaked into the L1–L2 disk during vertebroplasty of L1 and later caused a fracture of L2 inferiorly. The MR images obtained when the patient returned with new pain showed bone marrow edema and contrast enhancement. These abnormalities indicated a new fracture. The edema of the superior endplate was thought to be caused by the direct pressure of the hard cement. Edema of the lower half of the L2 vertebral body was also present. This was probably caused by a more generalized compression fracture of L2.

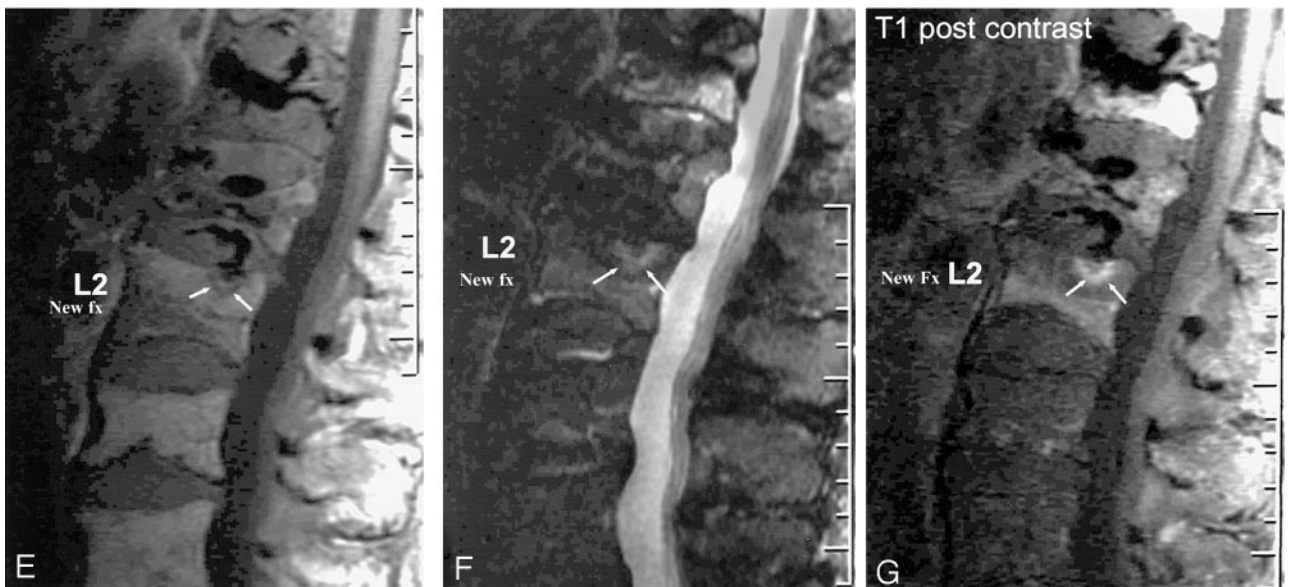
FIG 2. Continued

E, Sagittal view T1-weighted MR image obtained 25 days later, when the patient returned with new pain, shows a focal area of new bone marrow edema of L2 (arrows).

F, Sagittal view T2-weighted MR image obtained 25 days later, when the patient returned with new pain, shows a focal area of new bone marrow edema of L2 (arrows).

G, Contrast-enhanced sagittal view T1-weighted MR image shows enhancement, indicating a new acute focal fracture of L2 superiorly. The new fracture (arrows) is located immediately adjacent to the cement leakage into the disk.
