CASE REPORT

Intraspinal Leakage of Bone Cement after Vertebroplasty: A Report of 3 Cases

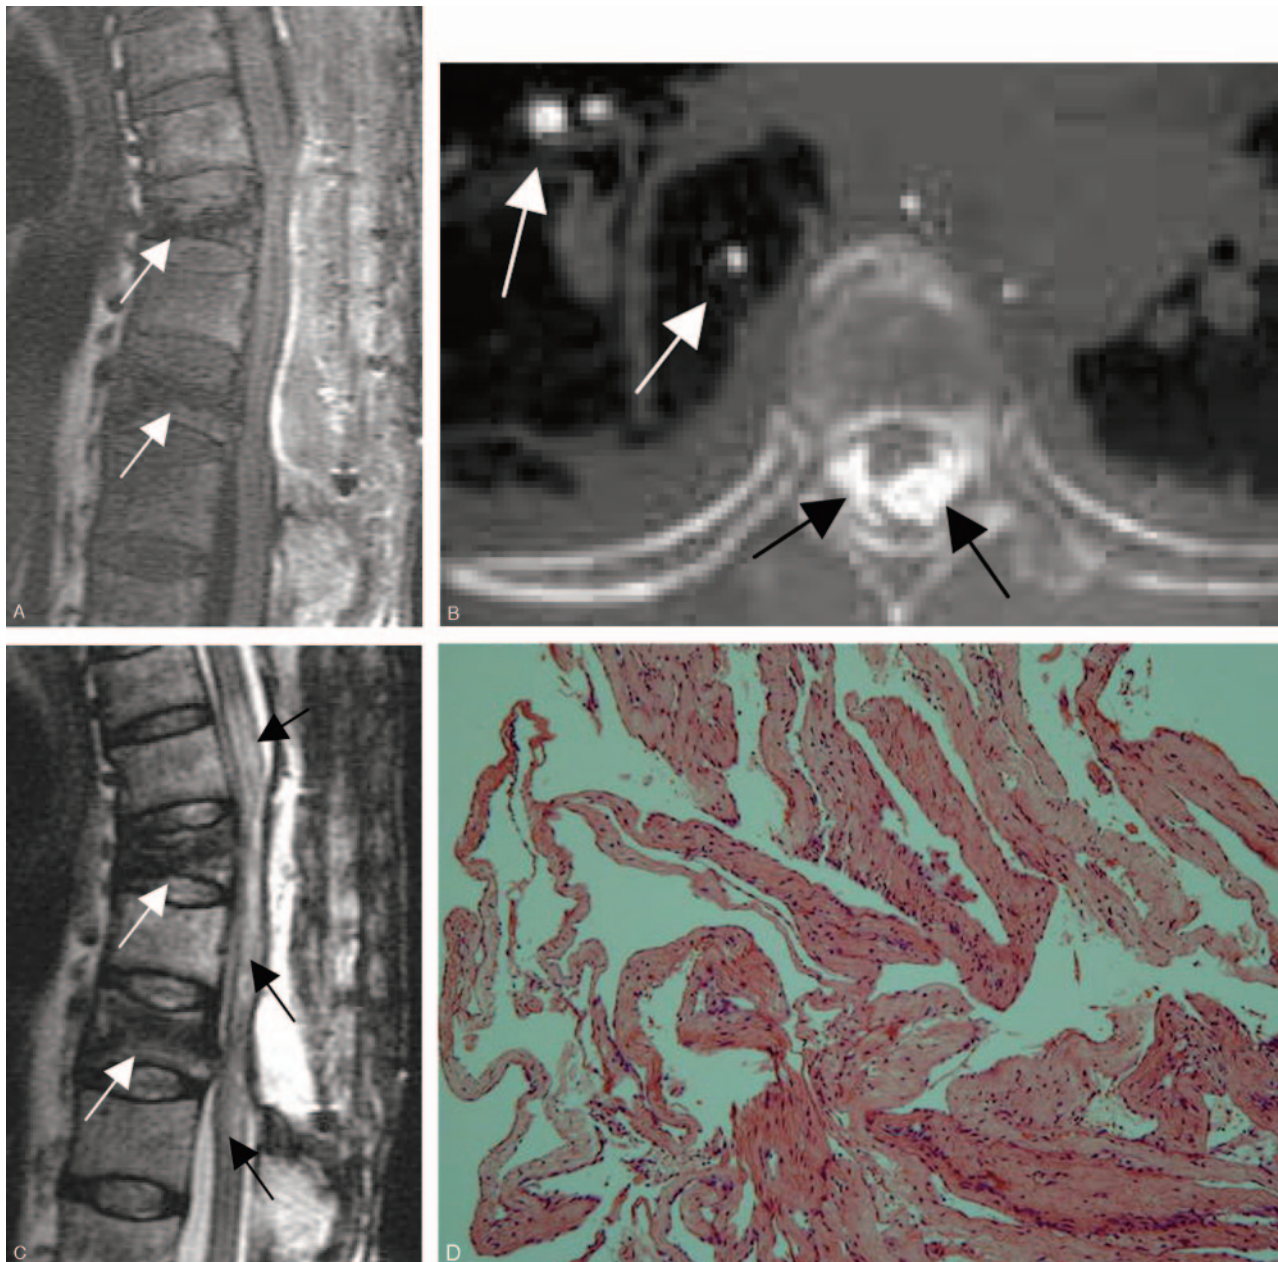
Fig 1. Case 1. *A*, Sagittal reconstructed CT scan performed same day as vertebroplasty shows postvertebroplasty appearance with hyperattenuated bone cement in T8, T10, and L1 vertebral bodies. Bone cement filled the anterior vertebral body, the posterior vertebral body, and the epidural space (arrows). The technical flaw in this case was allowing the bone cement to fill the posterior vertebral body and continue filling in the spinal canal.

B, Axial view at T7/T8 disk level performed same day as vertebroplasty shows bone cement in the epidural space (black arrows) and pulmonary arteries (white arrows).

C, T2-weighted MR imaging performed 50 days after vertebroplasty shows low-signal-intensity bone cement inside the anterior and posterior aspects of T8, T10, and L1 vertebral bodies (white arrows) and postlaminectomy appearance with bloody fluid collection (white arrowheads) causing posterior epidural compression to the spinal cord. There is high-signal-intensity change in the spinal cord on the T2-weighted images, because of compressive myelopathy or previous thermal injury. The posterior epidural compression and signal intensity change of the spinal cord are similar to the MR imaging performed 5 days after the second decompressive surgery. These changes were not present on MR imaging performed 2 days before vertebroplasty.

D, Fibrosis of arachnoid membrane (H&E stain).

Laminectomy for T11, T12, and L2, decompression of the previous laminectomy site of T8–10 and L2, and neurolysis from T8 to L2 were undertaken in our hospital 62 days after vertebroplasty. The spinal cord was pale at T8–10. The dura matter was yellow in color at T8–10, possibly from thermal injury as a result of vertebroplasty. A bone marrow biopsy revealed the presence of plasma cell myeloma, plasmacytic type (Lambda, IgA+). Microscopic examination of the removed arachnoid membrane revealed fibrosis (Fig 1D).

On the basis of the imaging clue, the technical flaw in this case was allowing the bone cement to fill the posterior vertebral body and continued filling in the spinal canal.

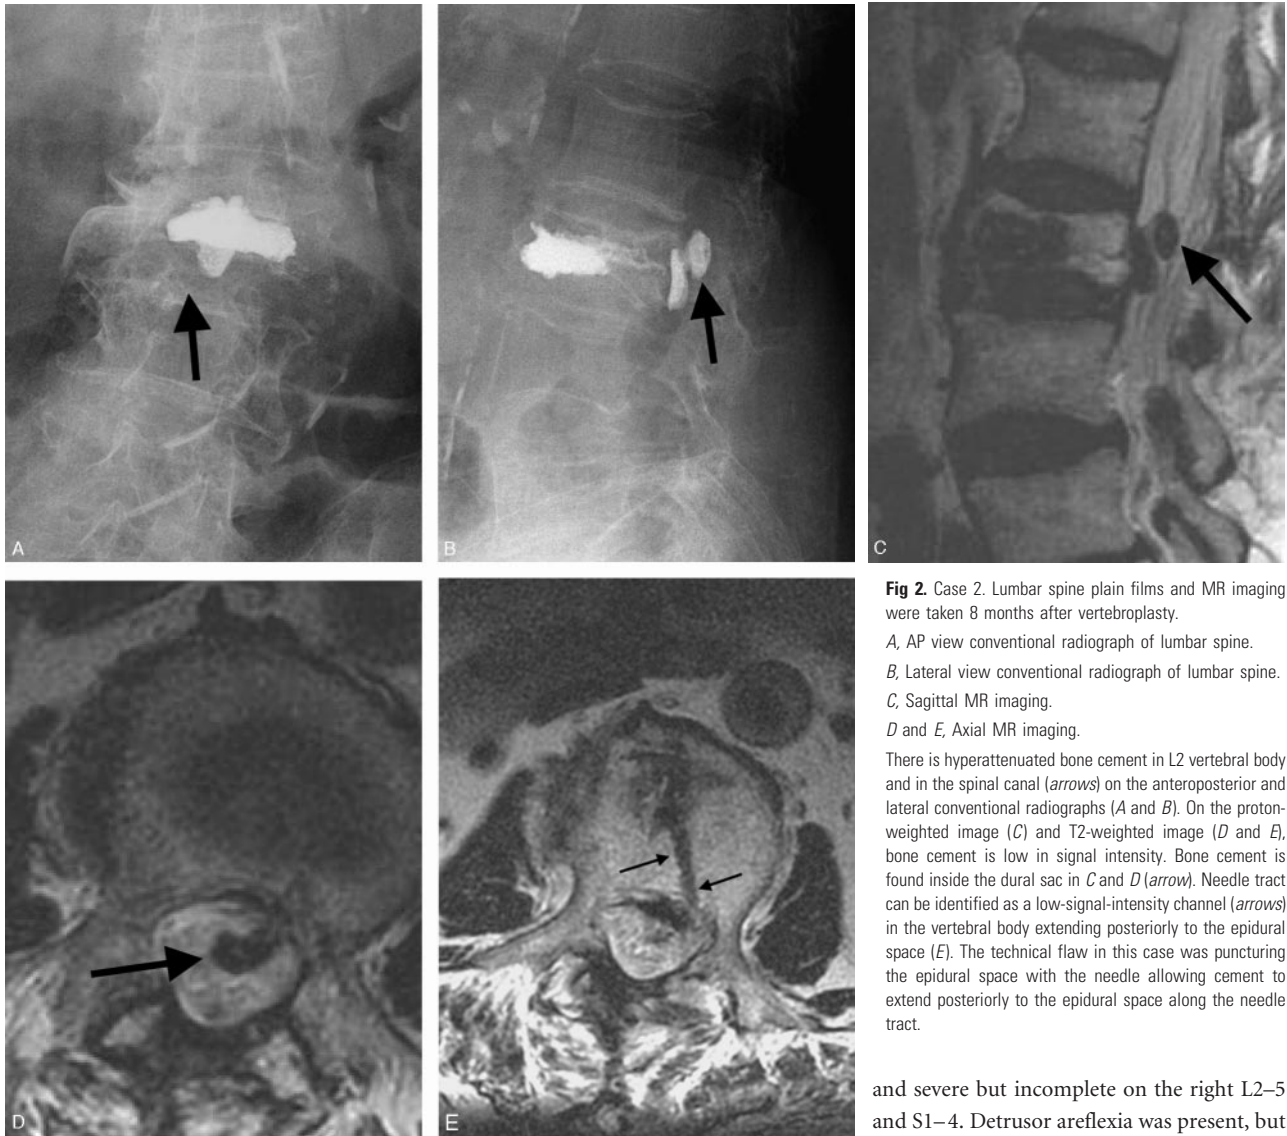
Fig 2. Case 2. Lumbar spine plain films and MR imaging were taken 8 months after vertebroplasty.

A, AP view conventional radiograph of lumbar spine.

B, Lateral view conventional radiograph of lumbar spine.

C, Sagittal MR imaging.

D and E, Axial MR imaging.

There is hyperattenuated bone cement in L2 vertebral body and in the spinal canal (arrows) on the anteroposterior and lateral conventional radiographs (A and B). On the proton-weighted image (C) and T2-weighted image (D and E), bone cement is low in signal intensity. Bone cement is found inside the dural sac in C and D (arrow). Needle tract can be identified as a low-signal-intensity channel (arrows) in the vertebral body extending posteriorly to the epidural space (E). The technical flaw in this case was puncturing the epidural space with the needle allowing cement to extend posteriorly to the epidural space along the needle tract.

Conventional radiographs and MR imaging 8 months after vertebroplasty showed epidural and intradural leakage of bone cement (Fig 2). She received rehabilitation only in our hospital. At follow-up 3 years after the leakage, she still had weakness of both lower extremities and could not walk on her own. She had urinary incontinence and constipation.

in this case was deviation of the needle, which broke the medial wall of the pedicle resulting in perforation of the dural sac by the needle. The needle tract could be identified on axial MR imaging (Fig 2E).

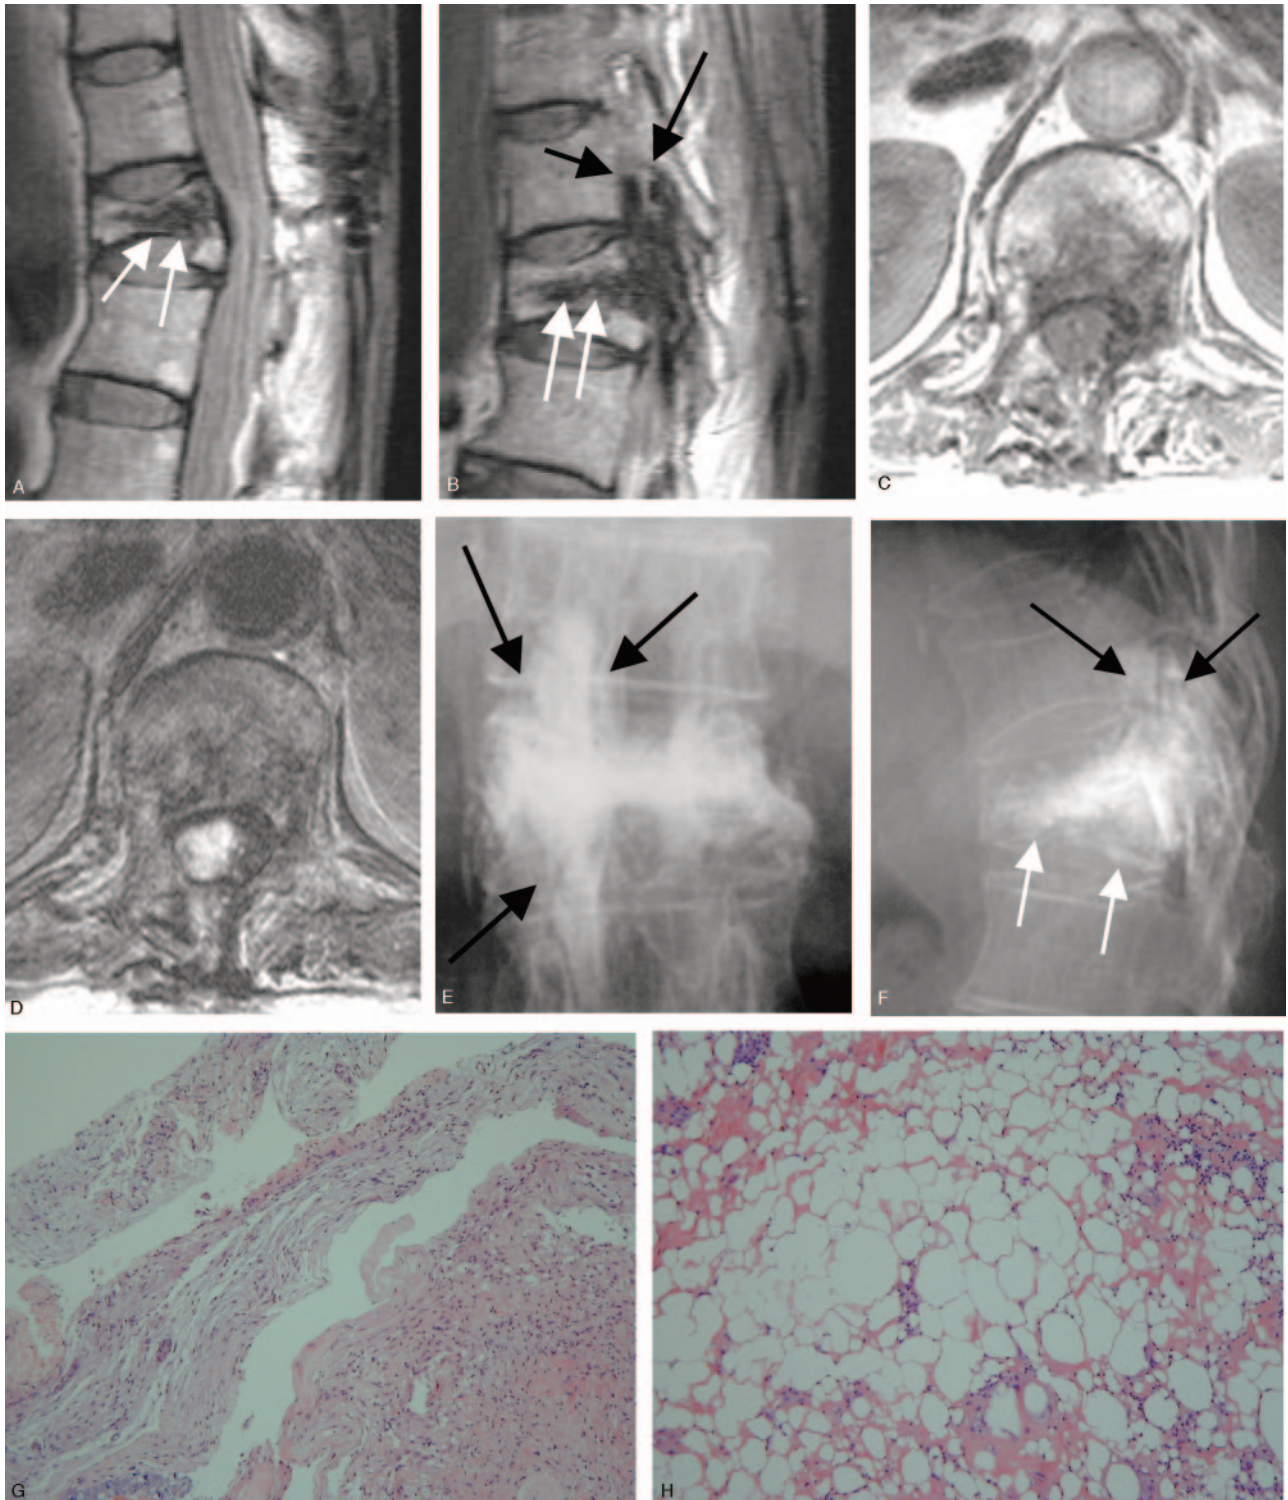
Fig 3. Case 3. MR imaging taken 73 days after vertebroplasty (A–D) and conventional radiographs of lumbar spine (E and F) taken 86 days after vertebroplasty. Dense bone cement is found in the anterior and posterior aspects of the vertebral body (white arrows), epidural space (short arrow), and intervertebral foramen (arrows). The technical flaw of this vertebroplasty was use of the wrong needle and possibly drilling past the epidural space.

G, Arachnoid membrane shows active fibrosis and thickening (H&E stain).

H, Epidural soft tissue shows fat necrosis and focal chronic inflammatory cell infiltration (H&E stain).
