## CT Demonstration of Cervical Vertebral Erosion by Tortuous Vertebral Artery

M. A. Dory<sup>1</sup>

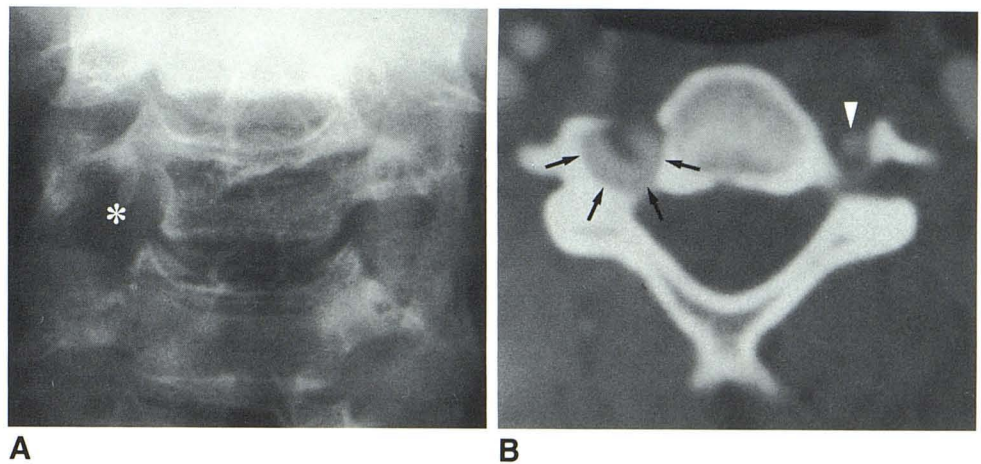
Fig. 1.—Case 1. **A**, Anteroposterior view of cervical spine. Enlargement of right C4–C5 intervertebral foramen (\*) caused by erosion of lateral aspect of C4 body and of inferior margin of its right pedicle. **B**, CT scan through middle of C4 body. Enlargement of right intervertebral foramen. After rapid intravenous injection of contrast medium, loop of right vertebral artery opacified (arrows), conforming to erosion of vertebral body. Left vertebral artery is normal (arrowhead).

A 26-year-old man underwent radiographic examination of the cervical spine because of a common mechanical nonradiating pain of a few weeks' duration that increased with motion. The only abnormality observed was an enlargement of the right C4–C5 intervertebral foramen due to a smooth erosion of the right aspect of the body C4 and of the inferior margin of its right pedicle (fig. 1A). The outline of this notch was sharp, with a fine sclerotic margin. There was no involvement of C5, particularly of its uncinete process.

CT demonstrated an enlargement of the whole right intervertebral foramen. After rapid intravenous injection of 50 ml of contrast me-

dium, a crescentic opacity became apparent, conforming to the margins of the enlarged foramen (fig. 1B) and corresponding with a well defined loop of the right vertebral artery. The left vertebral artery appeared normal, as a small round opacity in the left foramen. Arteriographic confirmation was considered superfluous. The complaints of the patient were so common and so benign that they were judged unrelated to the observed abnormalities; therefore, no specific therapy was instituted.

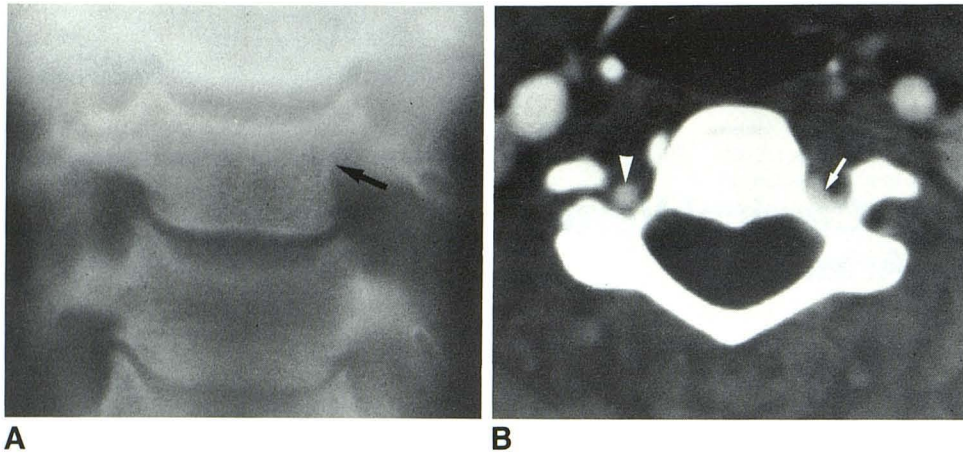
Fig. 2.—Case 2. **A**, Anteroposterior tomogram. Well defined erosion of left lateral aspect of body of C4 (arrow). **B**, CT scan of C4 after rapid intravenous injection of contrast medium. Opacified loop of left vertebral artery conforms to posterior and medial aspect of enlarged intervertebral foramen (arrow). Right vertebral artery is normal (arrowhead).

A 40-year-old woman complained of chronic pain along the left side of the neck without any objective symptom. Plain films and tomograms demonstrated mild degenerative lesions at C5–C6 and C6–C7. Enlargement of the left C4–C5 intervertebral foramen was caused by a well defined notch at the lateral aspect of the body of C4 extending to the anteroinferior margin of the left pedicle (fig. 2A). This notch had a fine sclerotic rim.

CT scans after rapid intravenous injection of a bolus of 50 ml of contrast medium demonstrated an opacified loop covering the posterior aspect of the enlarged C4–C5 left intervertebral foramen (fig. 2B). Since the relation between this abnormal vertebral artery and the complaints of the patient was uncertain, no specific therapy was instituted and nonsteroidal antiinflammatory drugs provided adequate improvement.
